Re: Las Olas Black Olive Tree Status Report

Las Olas Boulevard Black Olive Trees

CITY OF FORT LAUDERDALE

January 2024

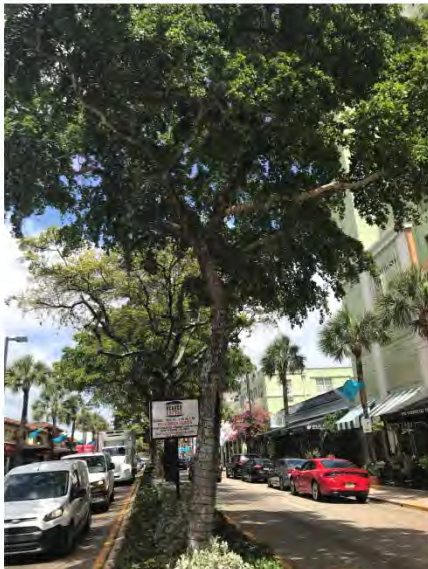
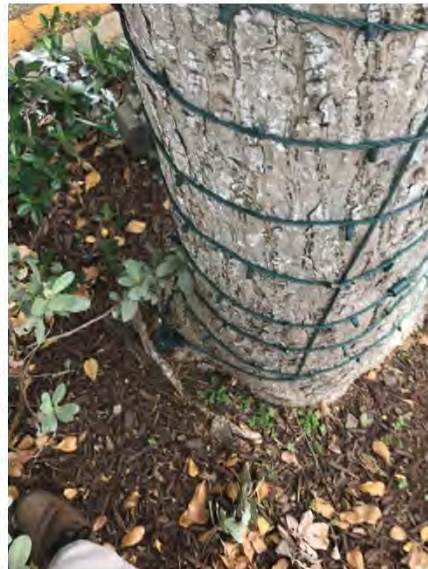
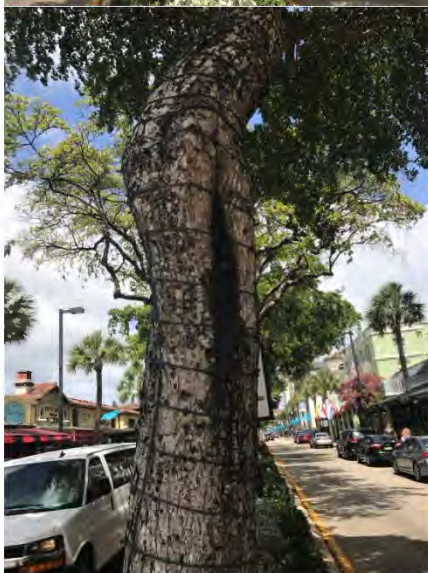
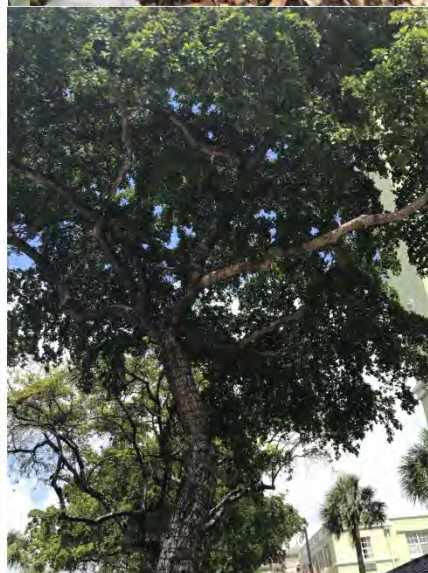
Tree 1

Black olive ~~14.5"~~14.75" dbh

Over lifted canopy, flush cuts, trunk is partially dog legged, minor branch deadwood, Live Crown Ratio 28%, girdling roots, **mechanical root zone damage**, **32.5' canopy spread diameter** and the tree is in fair condition.

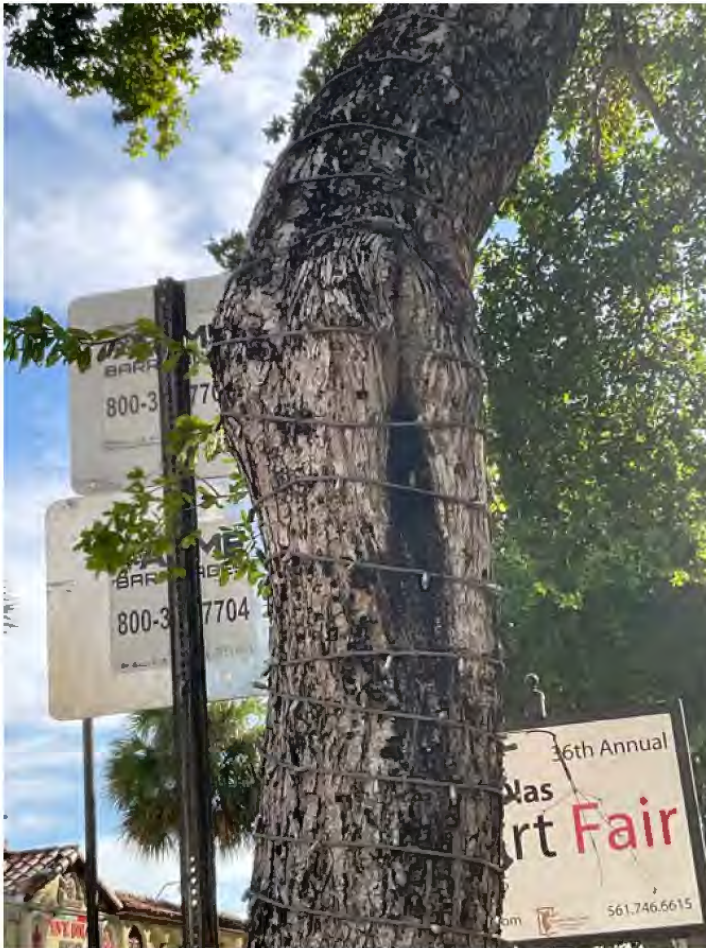
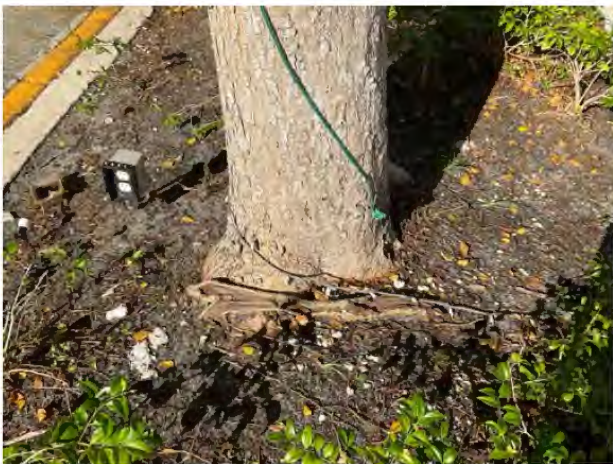
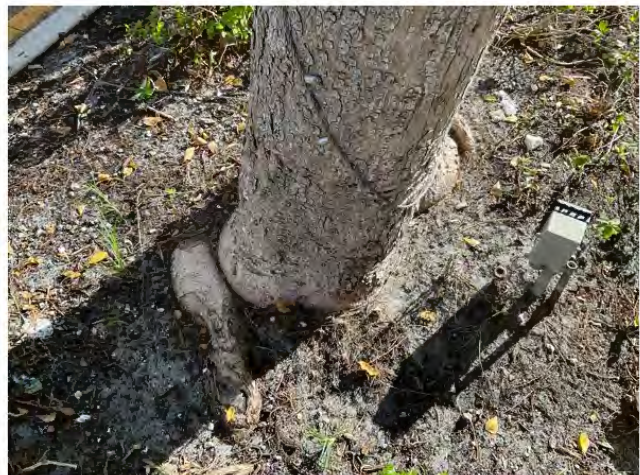
Tree 1
October 2023 update

15.25" DBH

No significant changes in health or condition from previous observations noted.

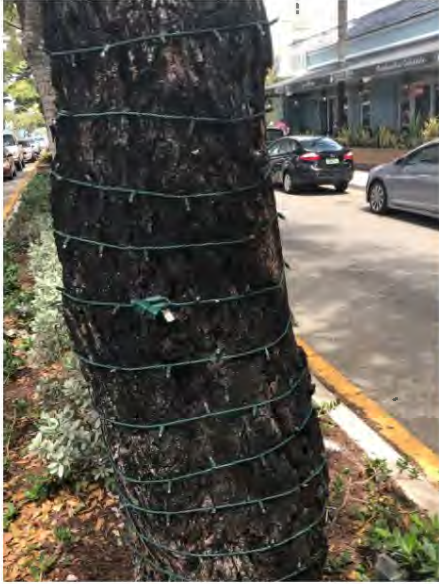
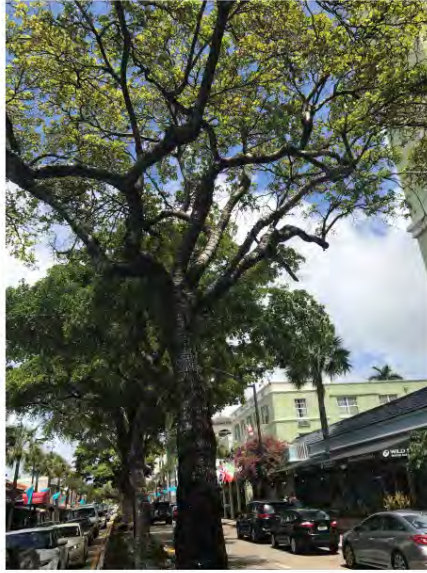
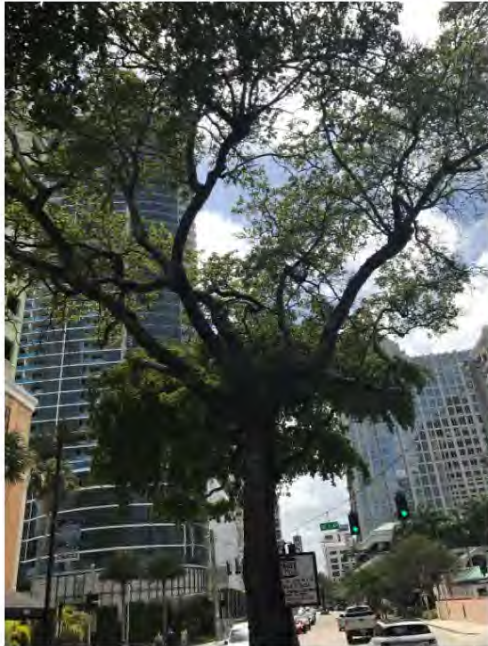
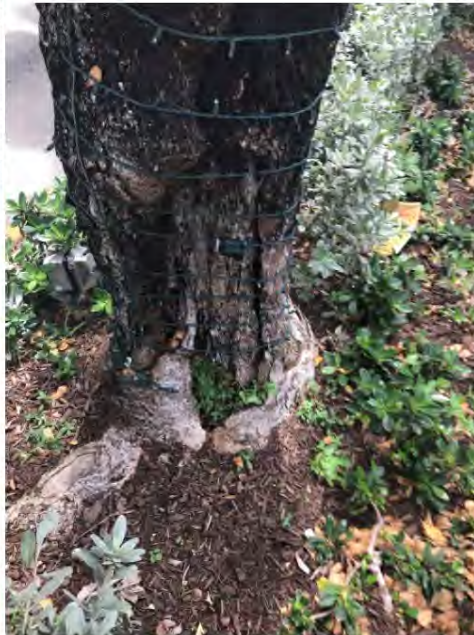
Tree 2

Black olive 19" dbh

Over lifted canopy, significant trunk decay from possible vehicle strike, bark loose and falling off in large sections, large basal cavity, sap oozing from trunk, poor live crown ratio less than 10%, significant deadwood and leaf chlorosis 17-20' spread. Tree condition is very poor.

Tree was removed in January 2019 due to advanced decay and vertical cracking of trunk.

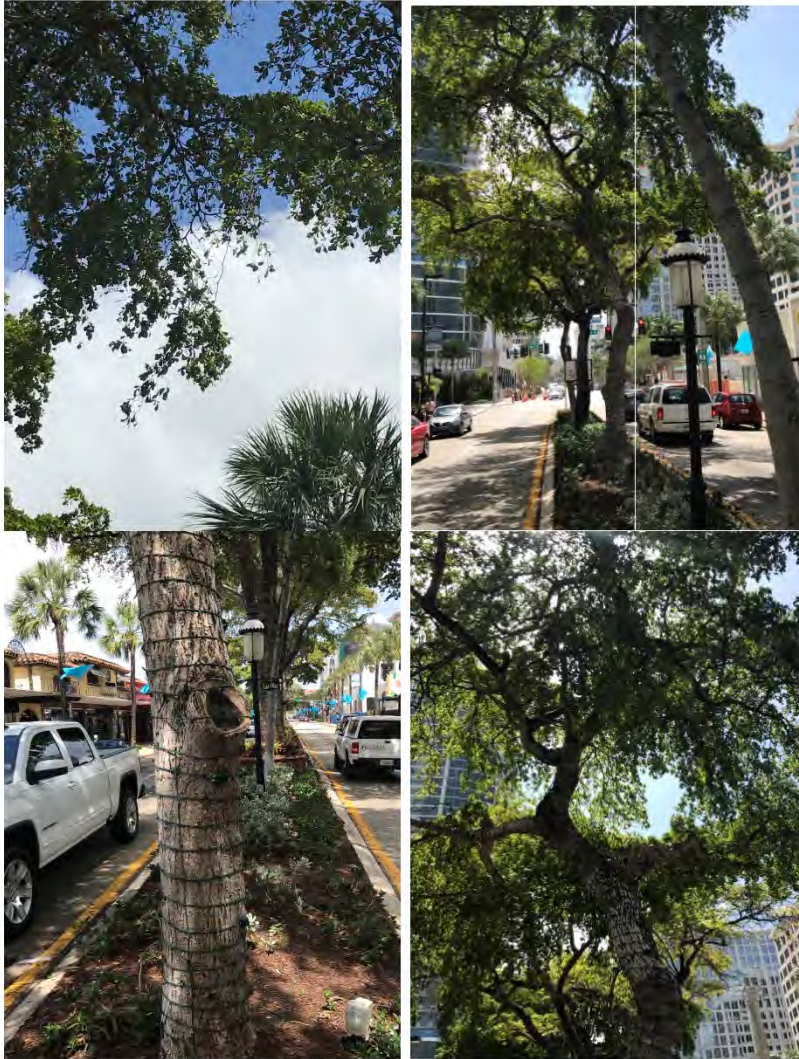
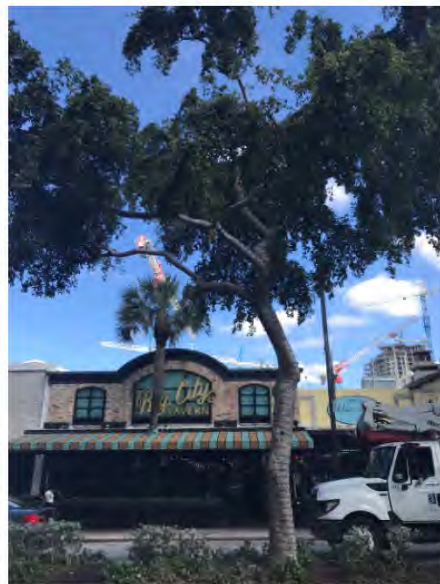
Black olive 15.5" 15.9" dbh
Over lifted canopy, evidence of storm damage related failures, leaf chlorosis, small branch deadwood, live crown ratio 20-25% tree condition is fair/poor, 27.63' canopy spread diameter.

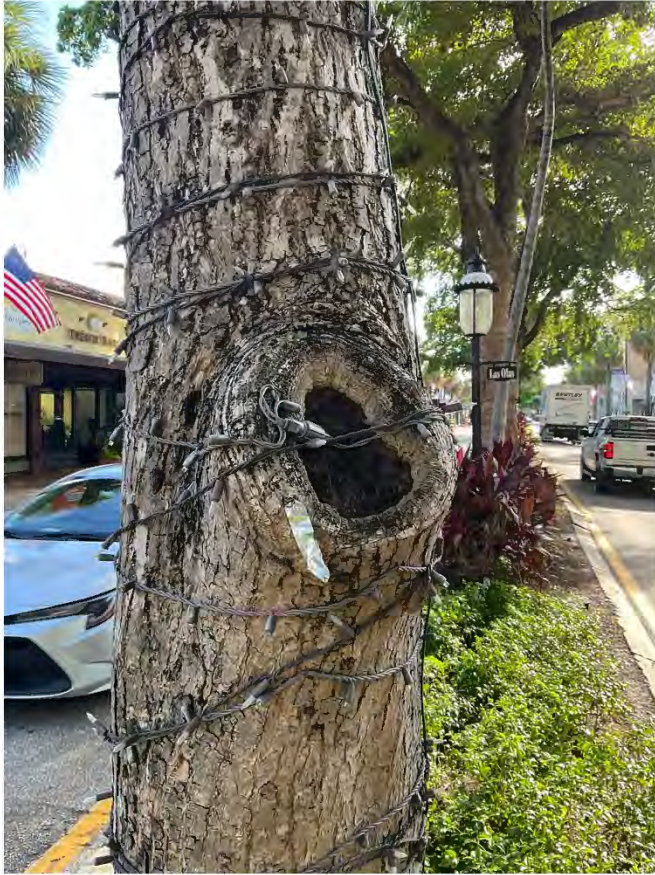
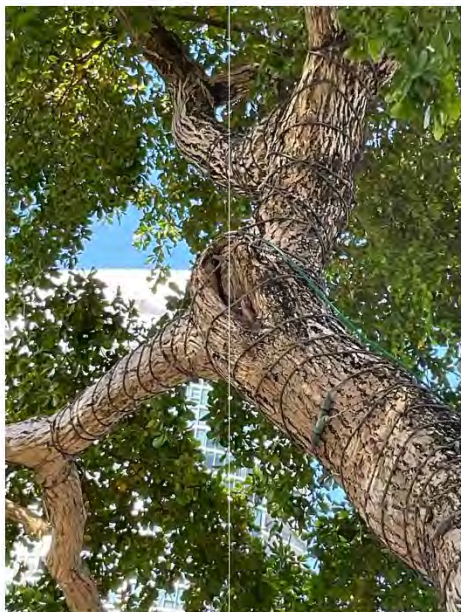
October 2023 update

16.25" DBH

No significant changes in health or condition from previous observations noted.

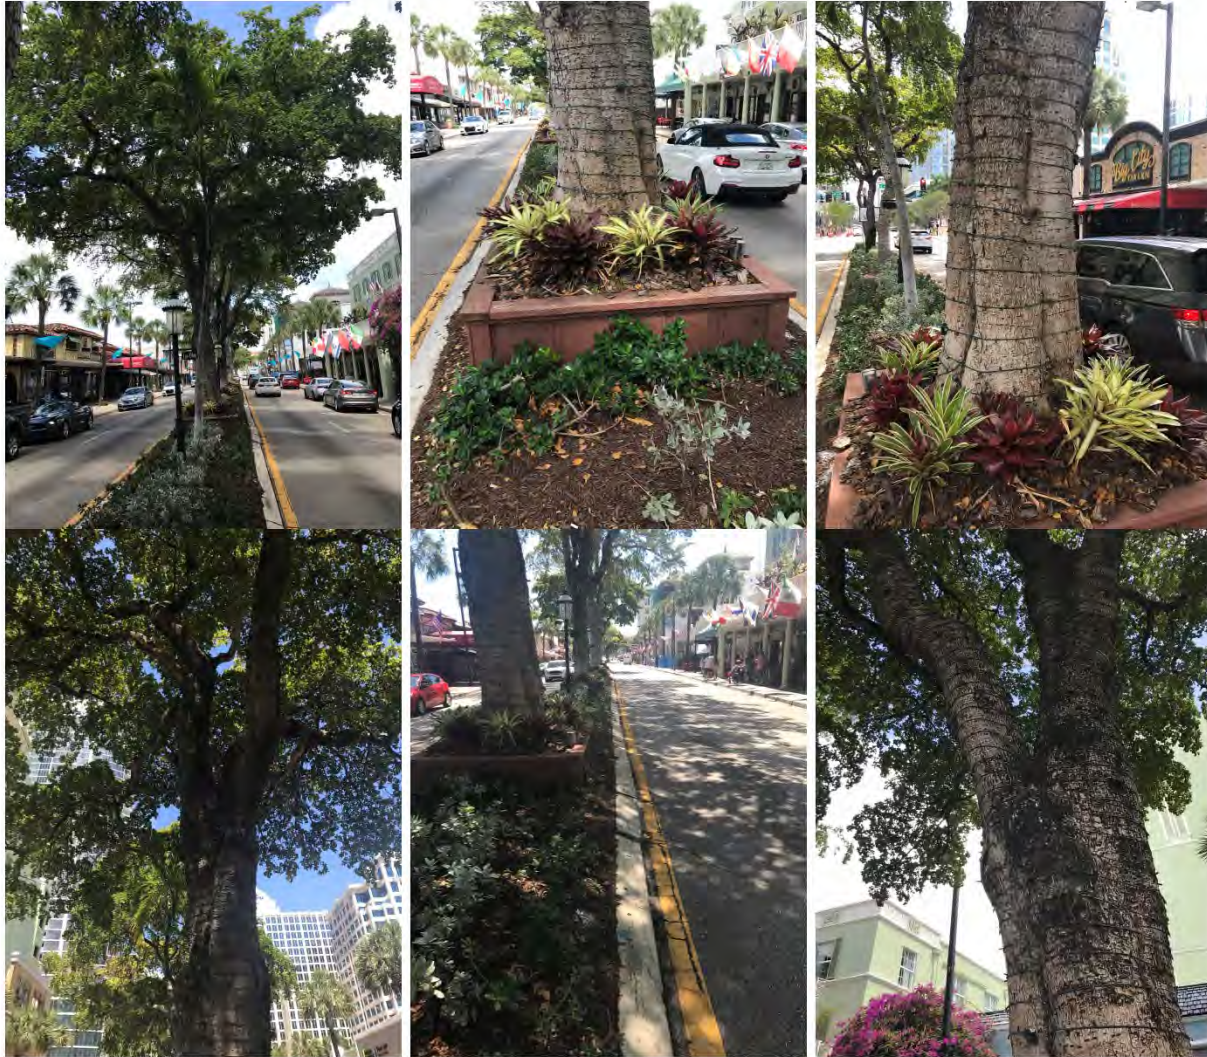
Black olive 27" 27.5" dbh

Over lifted canopy, poor structure (poor angles of attachment/included bark), swollen/sunken areas of trunk indicating possible presence of decay, leaf chlorosis, live crown ratio of 35-40%, visible decay with carpenter ants present, tree condition is fair, 43.9' canopy spread diameter, inside of raised planter box with evidence of curb uplift from roots.

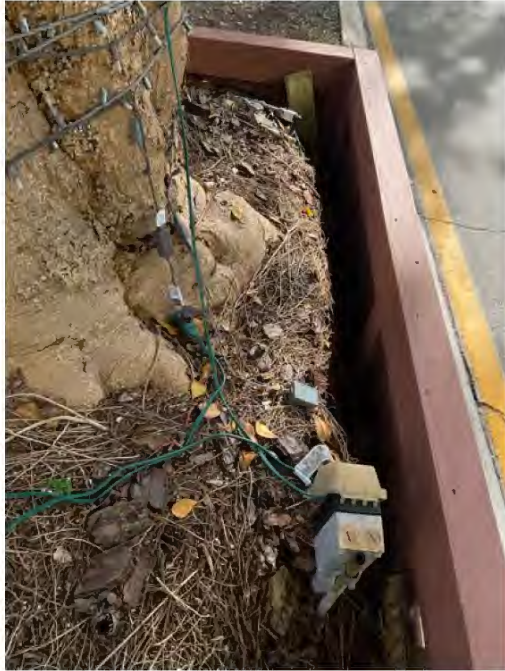
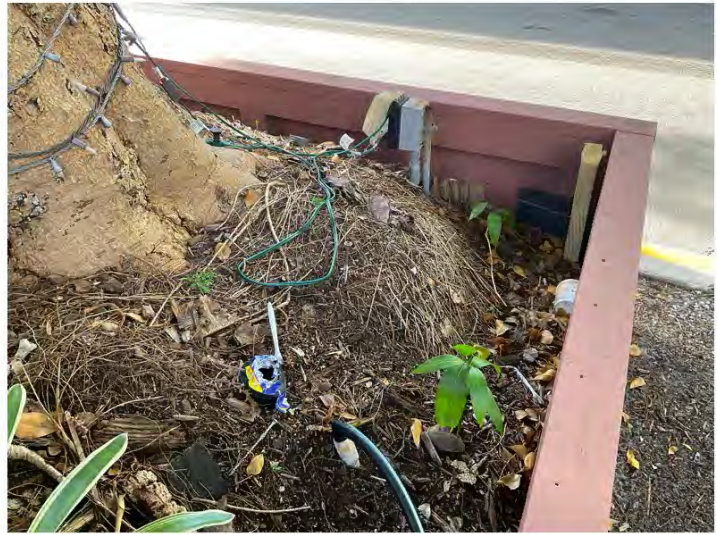
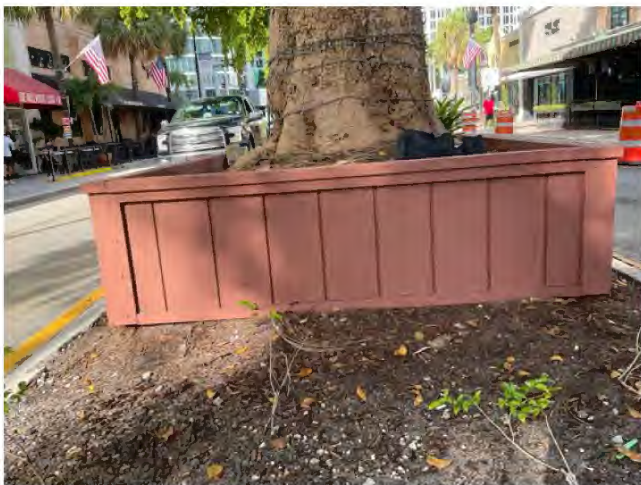
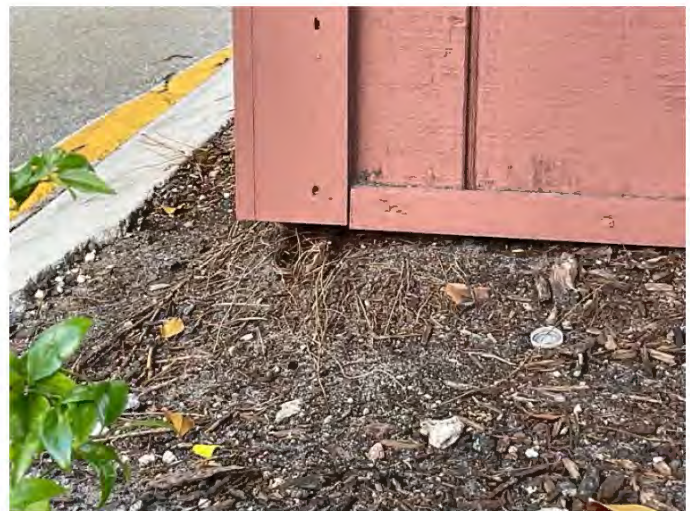
October 2023 update

27.75" DBH

Roots appear to be lifting planter box above existing grade. Minimal trunk growth over the four-year period since last measured. Tree remains in fair condition.

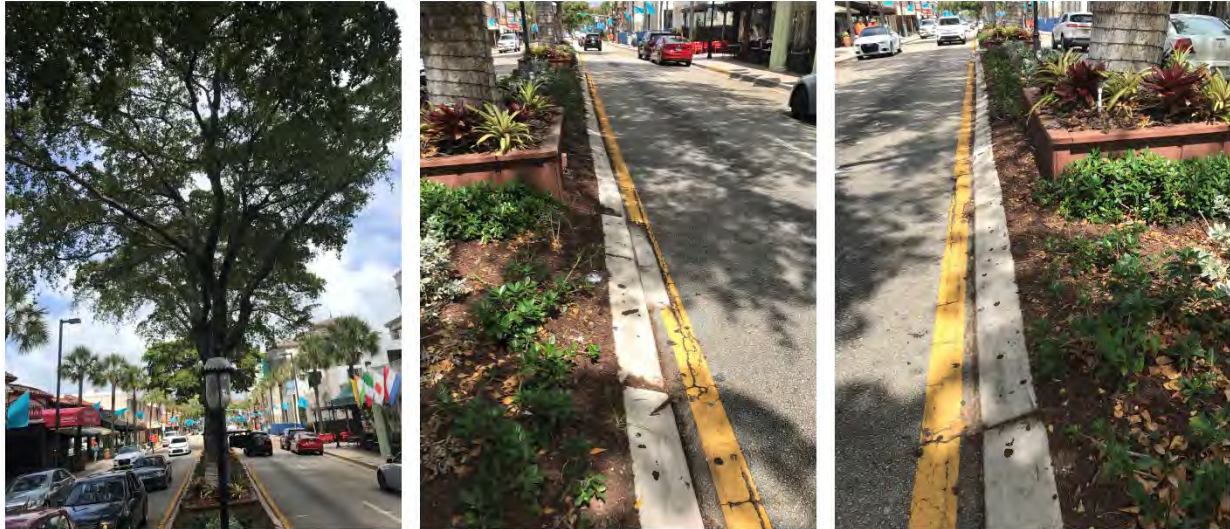
Black olive ~~26"~~ 26.65" dbh

Over lifted canopy, poor structure (codominant stems with included bark), small branch deadwood, leaf chlorosis, live crown ratio of 20-25%, 44.2' canopy spread diameter, inside of raised planter box with evidence of curb uplift from roots, tree condition is fair/poor.

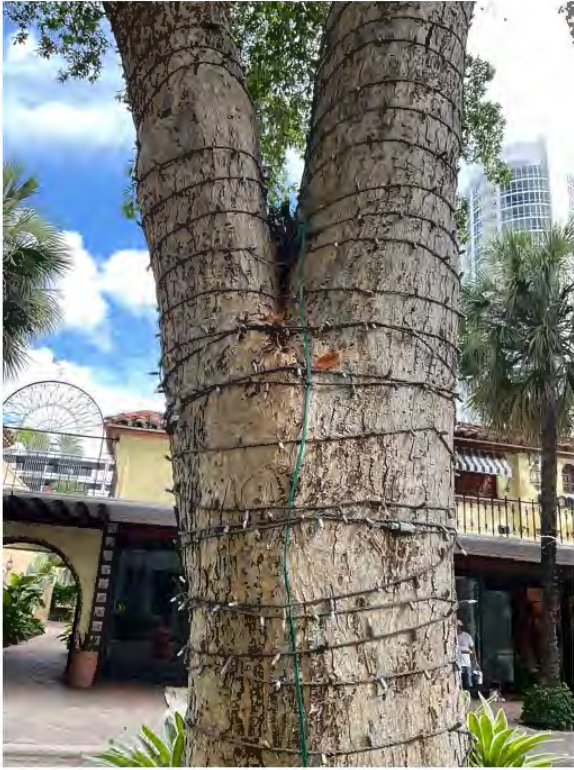
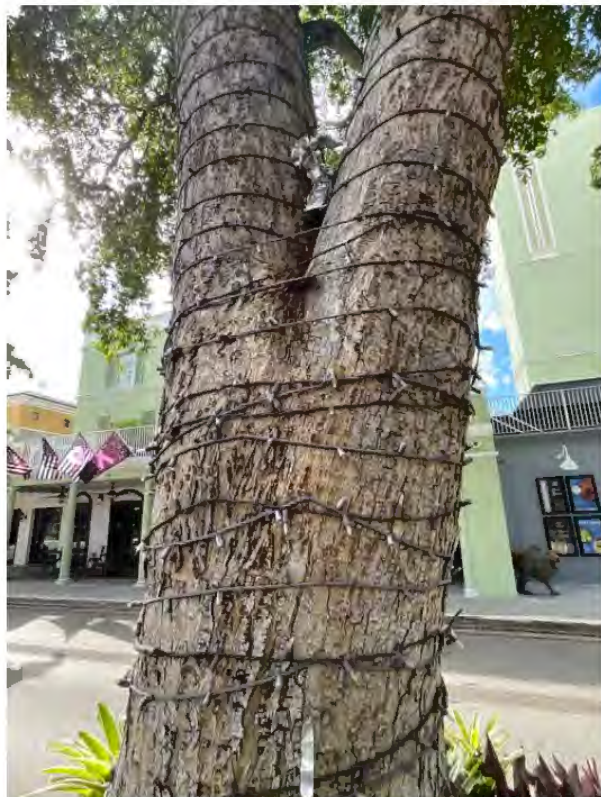
October 2023 update
27.25" DBH

No significant changes in health or condition from previous observations noted.

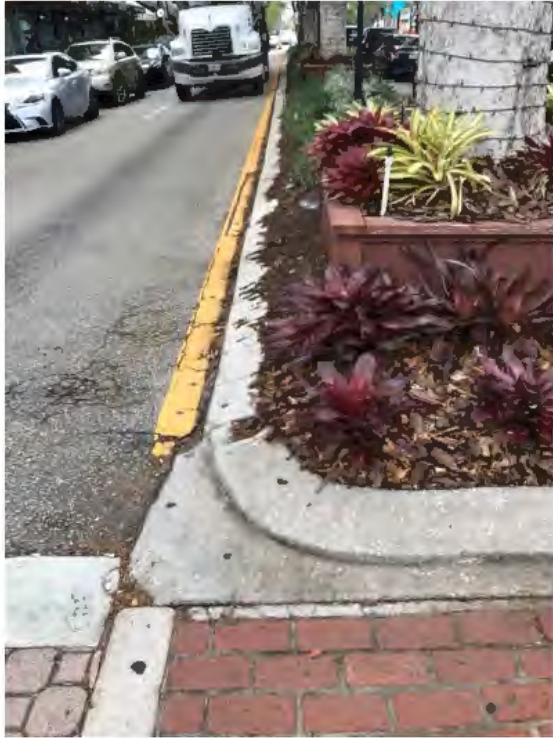
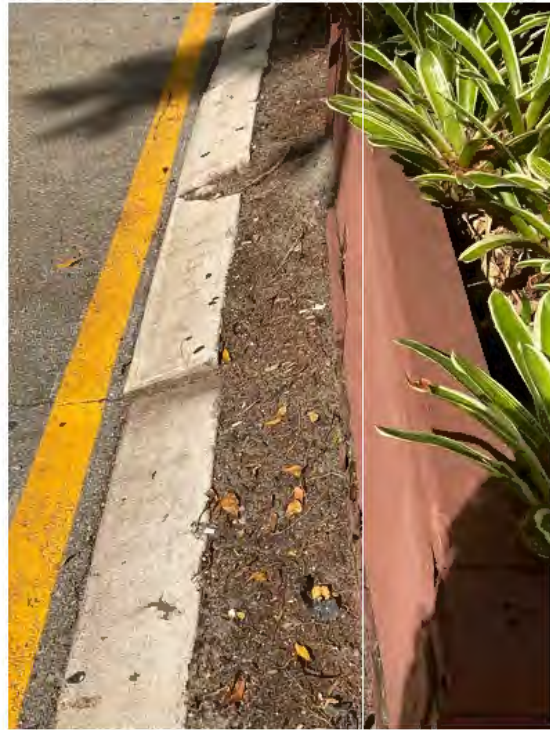
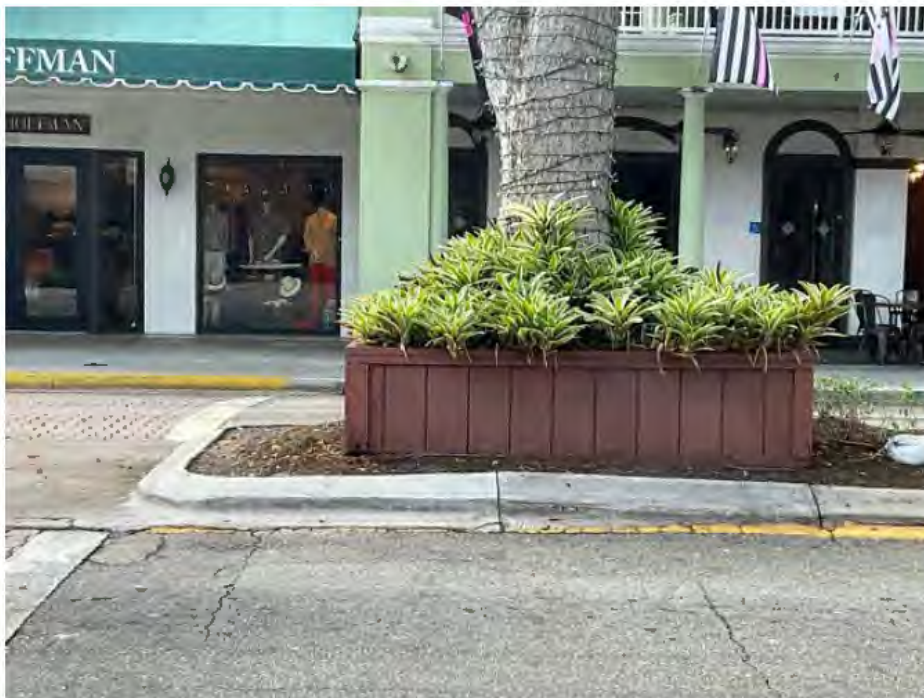
Tree 6
October 2023 update
26.5" DBH

No significant changes in health or condition from previous observations noted.

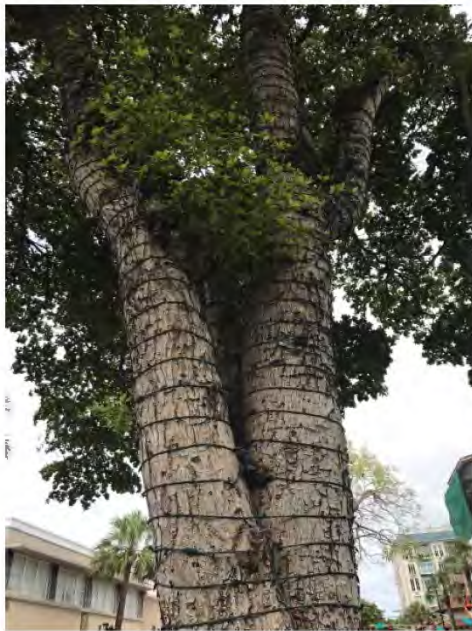
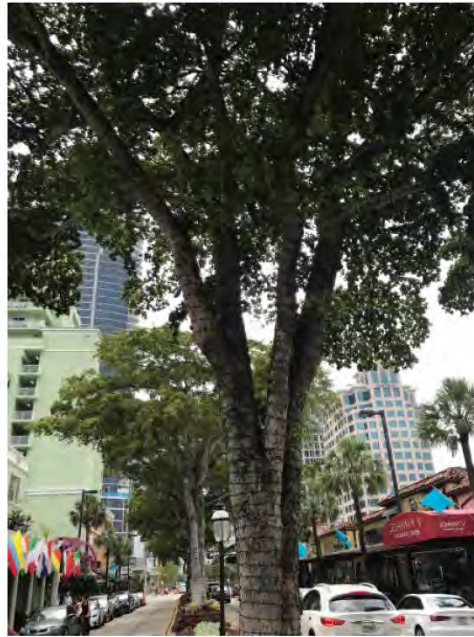
Black olive 23.75" dbh

Over lifted canopy, sunken areas present in trunk indicating possible decay, poor structure (codominant stems with included bark), small branch deadwood, improper pruning cuts, live crown ratio 40-45%, inside of raised planter box with evidence of curb uplift from roots, 37.92' canopy spread diameter, tree condition is fair.

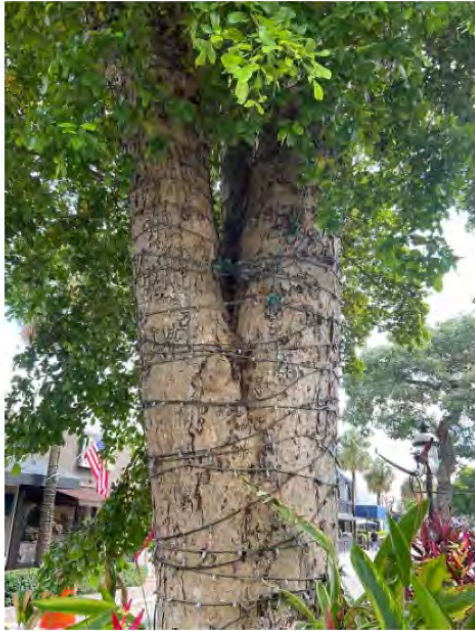
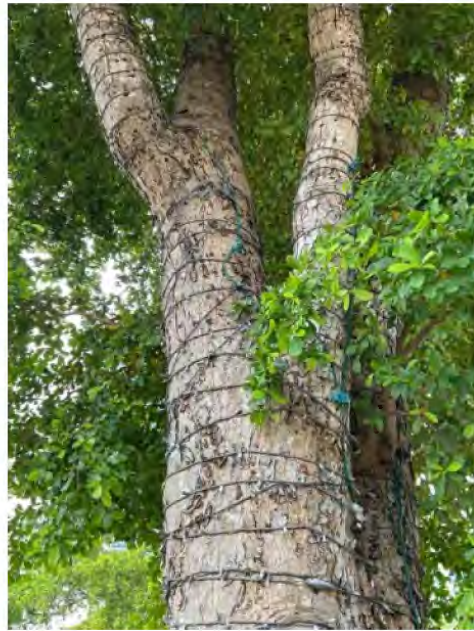
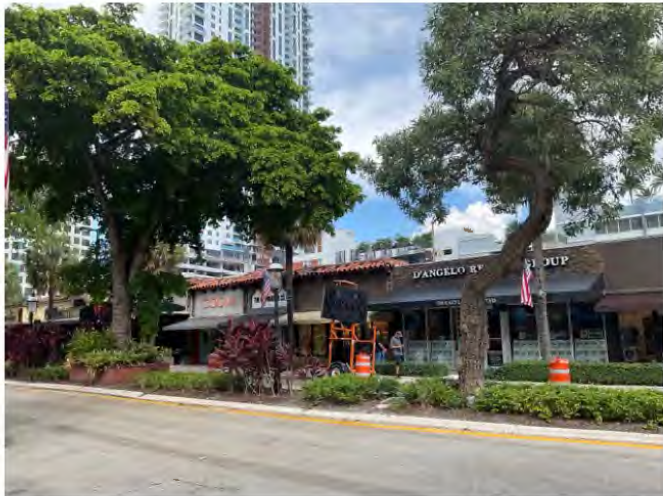
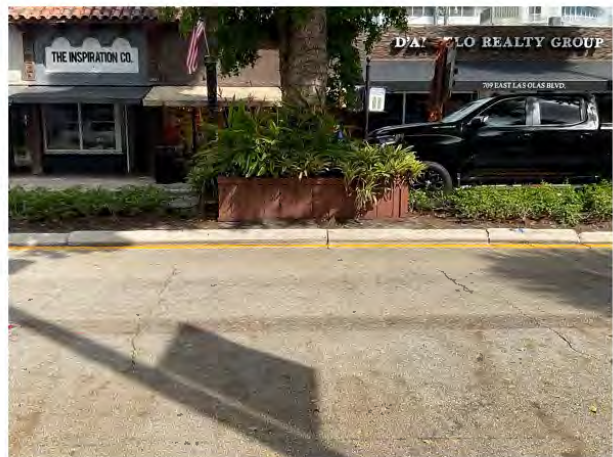
Tree 7
October 2023 update
24" DBH

No significant changes in health or condition from previous observations noted.

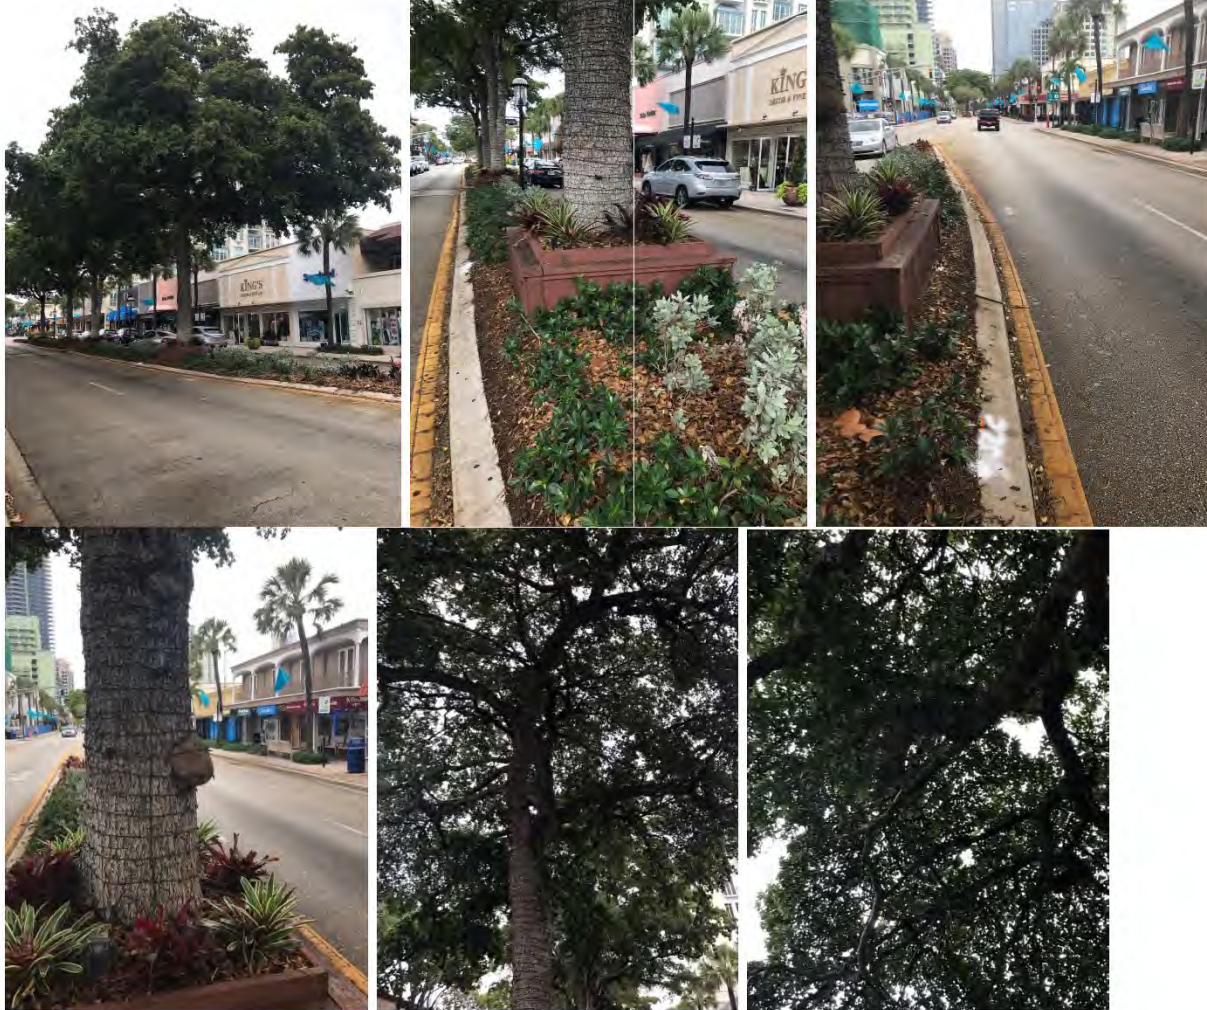
Tree 8

Black olive 23" 23.25" dbh

Over lifted canopy, gall present on trunk, past evidence of scaffold limb failure present, small branch deadwood, live crown ratio 50%, 42.55' canopy spread diameter, tree has NW lean with additional root zone uplift on south side, inside of raised planter box with evidence of curb uplift from roots, tree condition is fair.

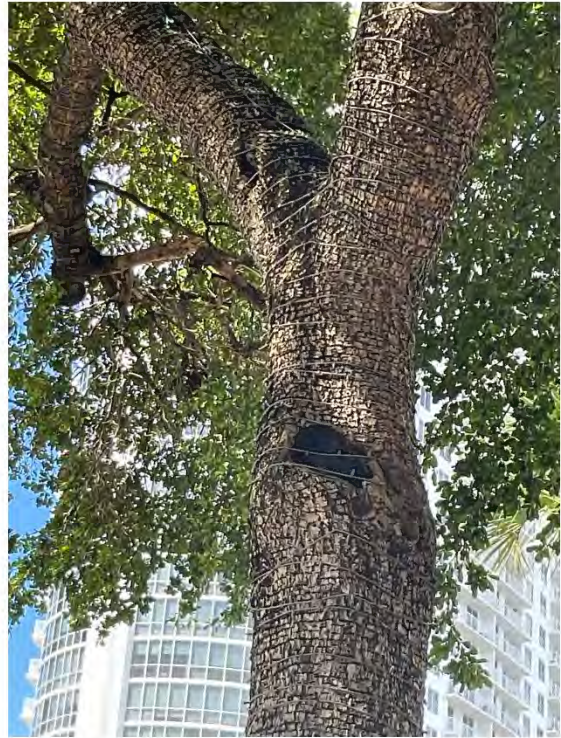
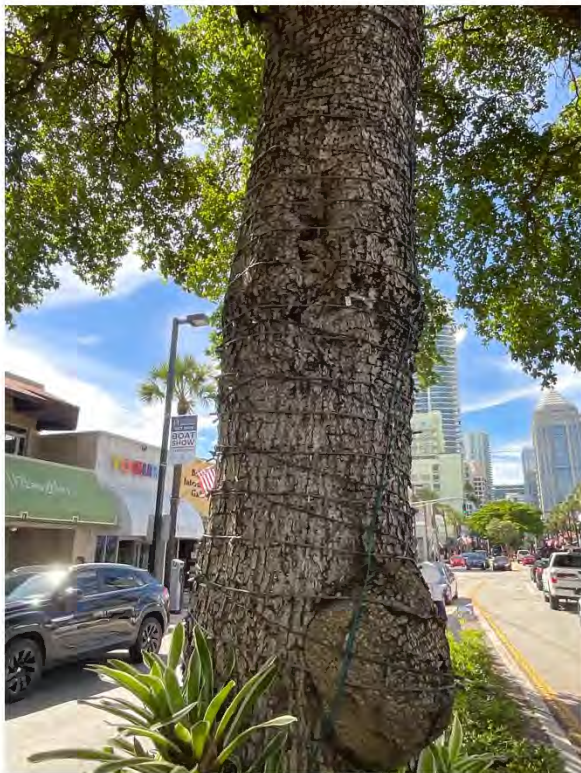
Tree 8

24" DBH

No significant changes in health or condition from previous observations noted.

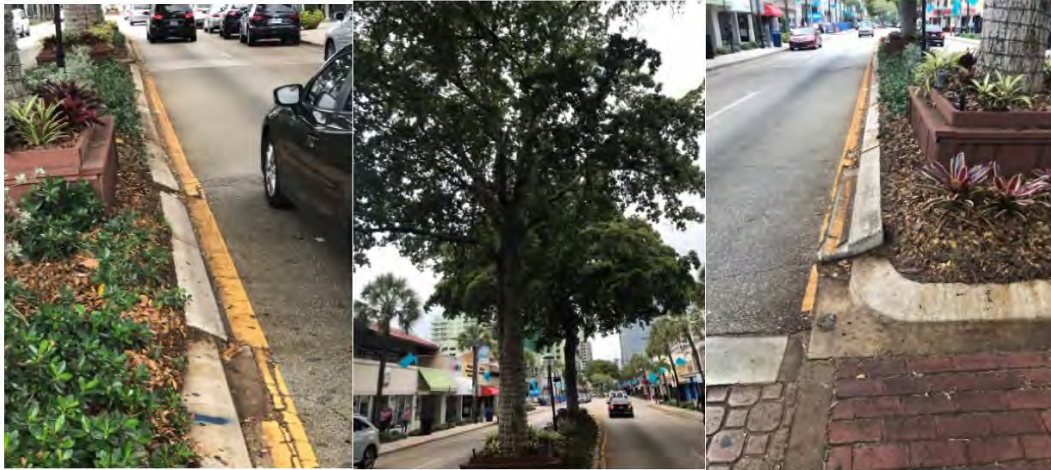
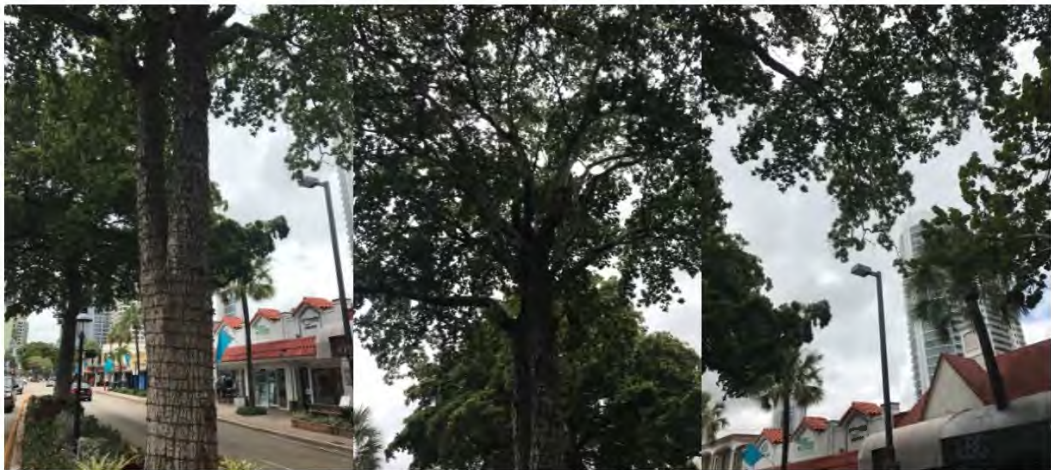
Tree 9

Black olive 22" 22.5" dbh

Over lifted canopy, poor structure (codominant stems with included bark), small branch deadwood present, live crown ratio 23%, leaf chlorosis, canopy spread 37.45' canopy spread diameter, inside of raised planter box with evidence of curb uplift from roots, tree condition is fair/poor.

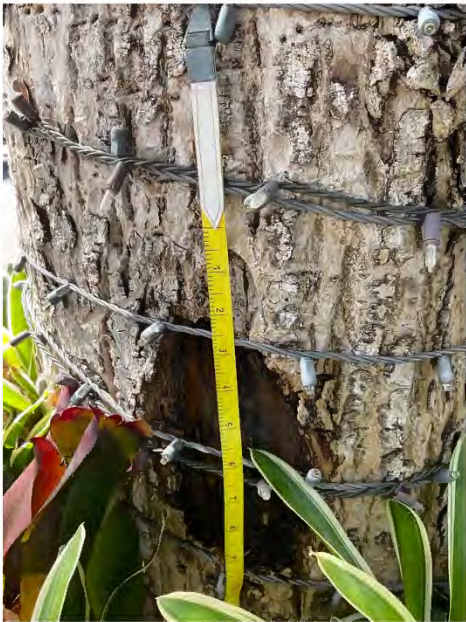
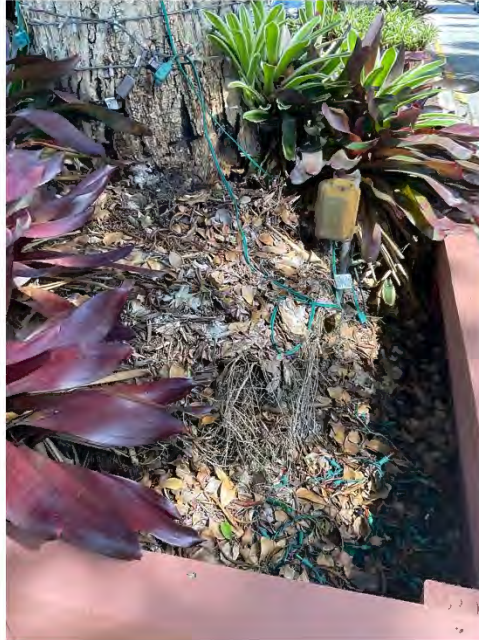
Tree 9

22.75" DBH

Decay is visibly present causing patches of bark to slough off. Condition is poor.

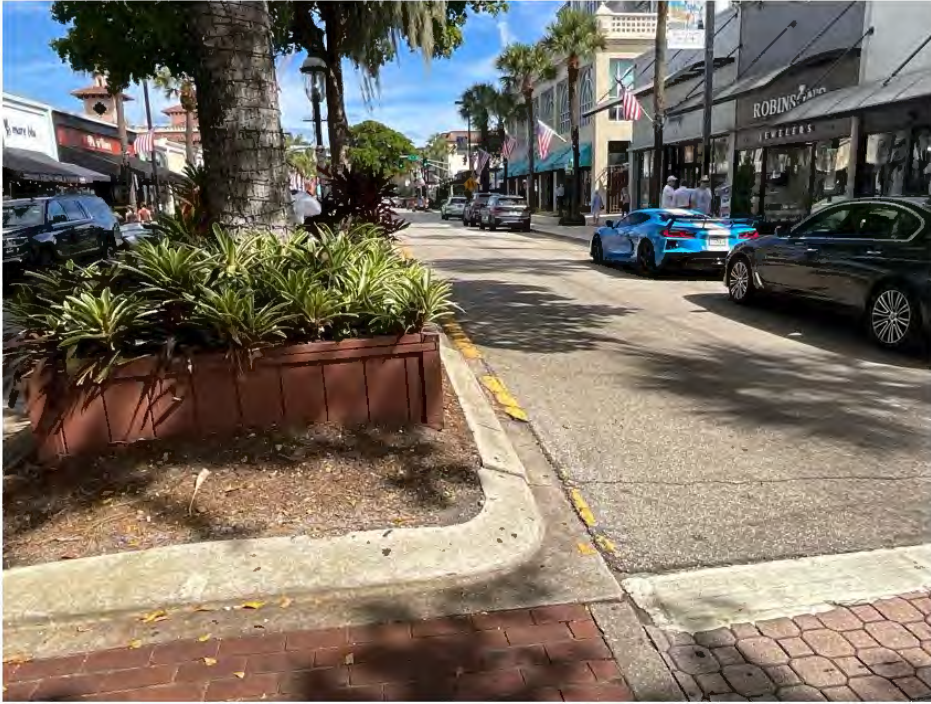
Tree 10
October 2023 update
17.75" DBH

Additional uplift of curbing.

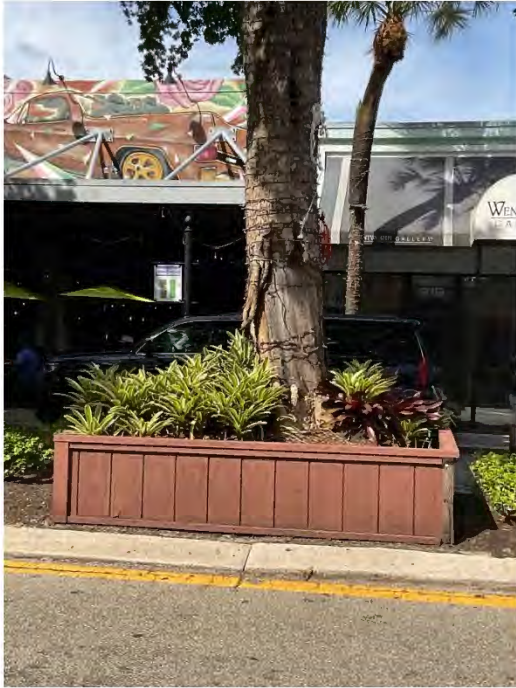
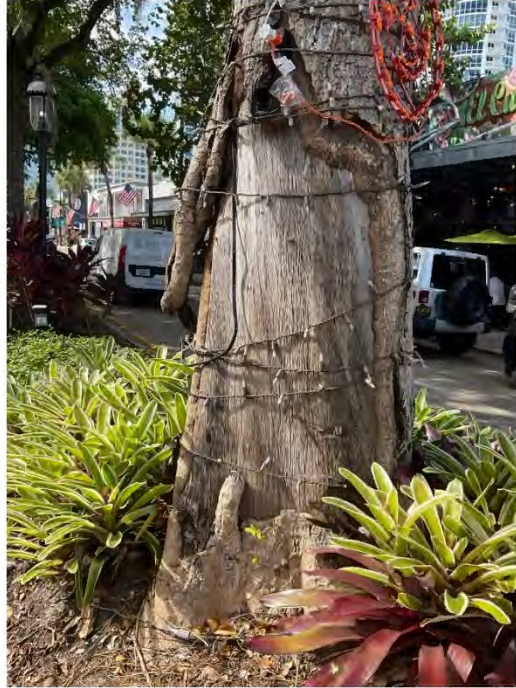
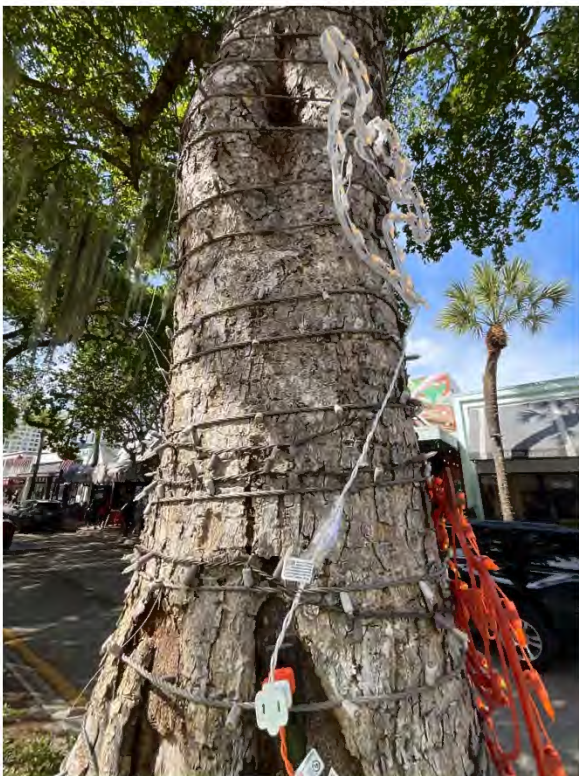
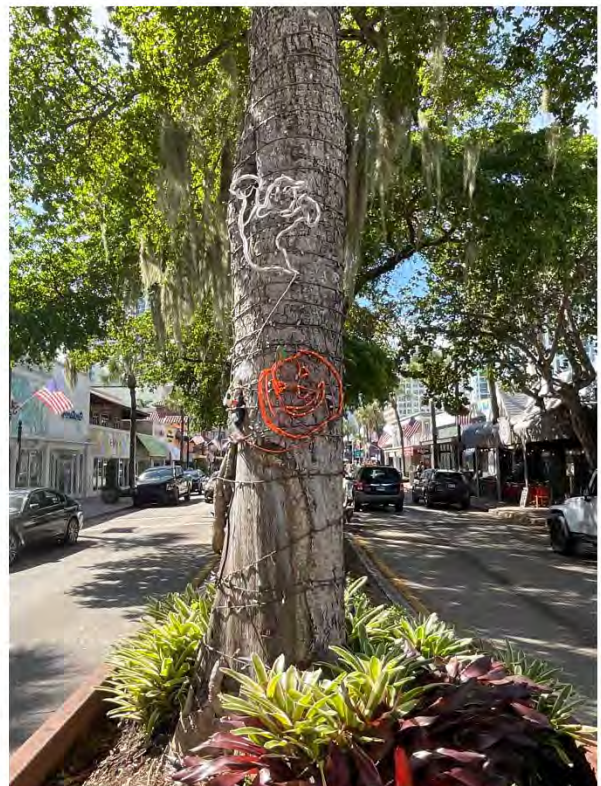
Tree #1

19" DBH

Large patches of bark are missing. Wound response growth is present but is not likely to provide sufficient coverage to restore structural integrity of trunk. Deadwood is visible on both sides of trunk. Tree condition has declined to poor.

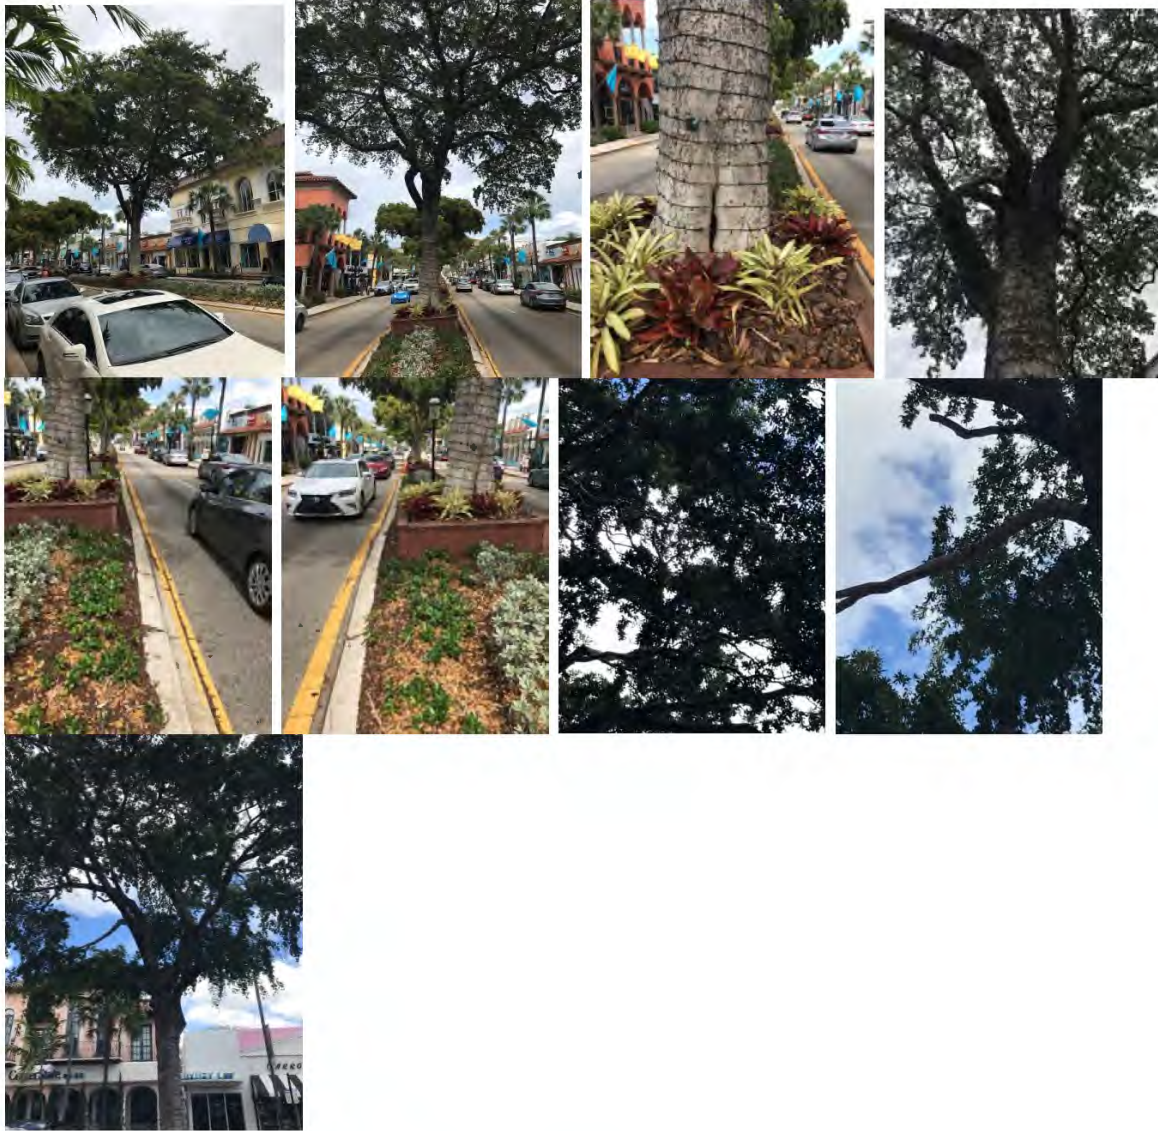
Tree 12

Black olive 25" 25.75" dbh

Over lifted canopy, old trunk wound from either flush cut or vehicle strike, flush cuts, poor structure (poor angles of scaffold limb attachment), large branch deadwood present, live crown ratio 25%, 47.01' canopy spread diameter, inside of raised planter box with evidence of curb uplift from roots, tree condition is fair.

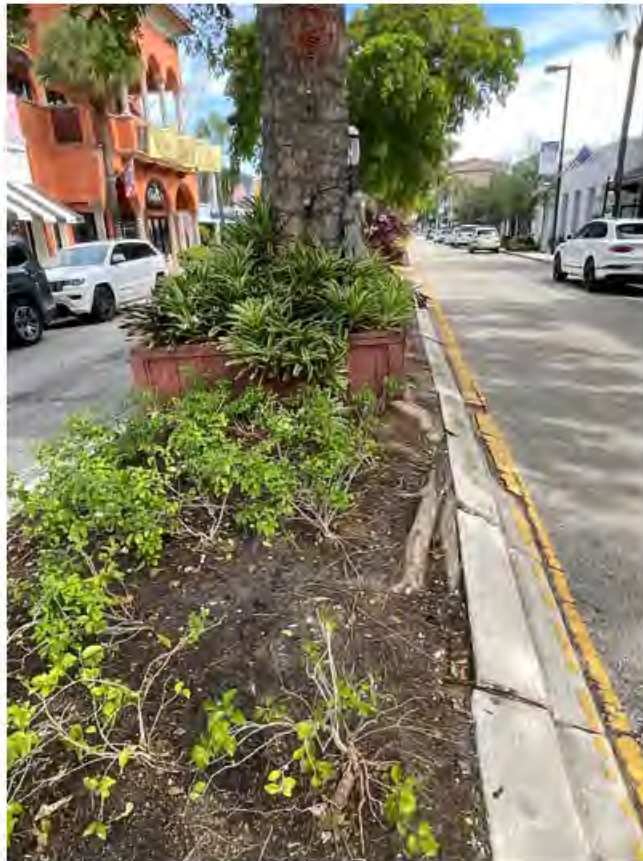
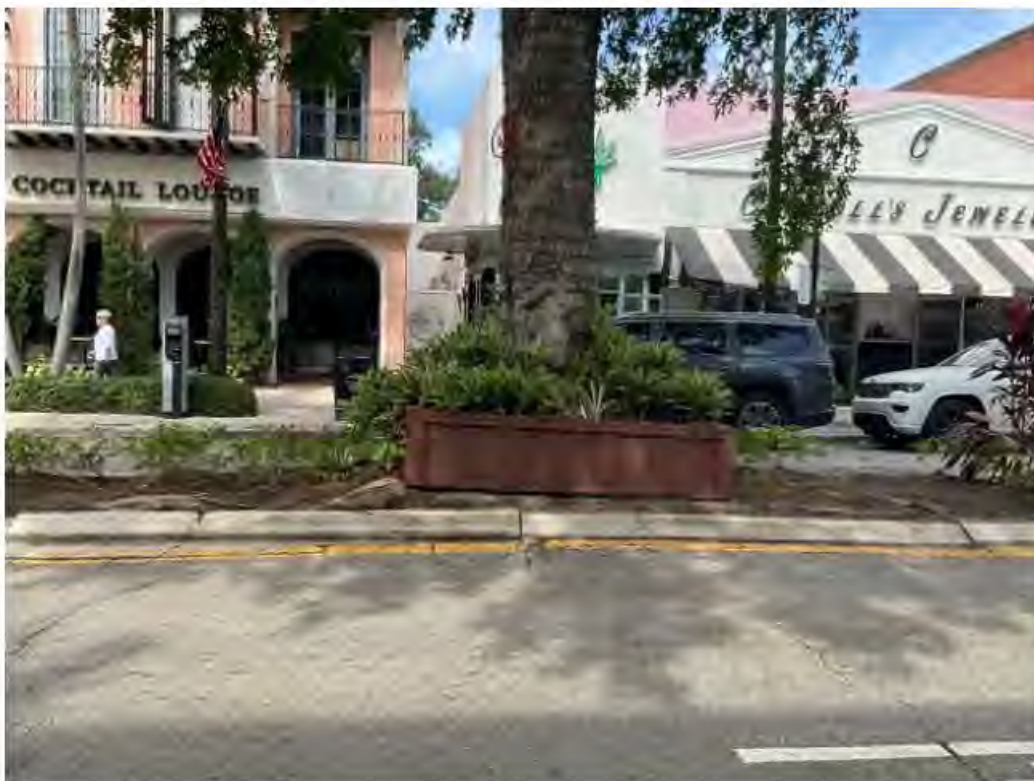
Tree 12

26" DBH

No significant changes in health or condition from previous observations noted.
