Re: Las Olas Black Olive Tree Status Report

Las Olas Boulevard Black Olive Trees

CITY OF FORT LAUDERDALE

January 2024

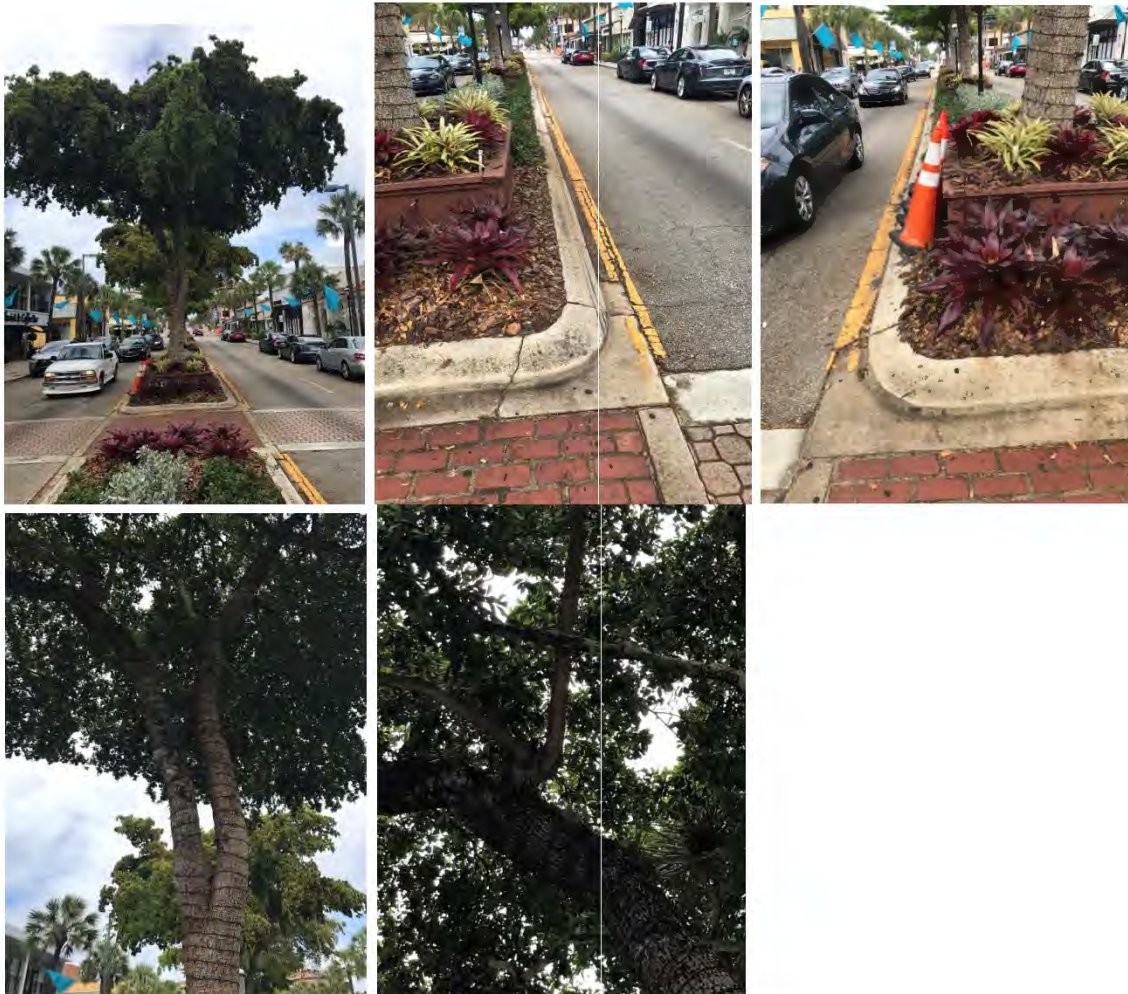
Tree 13

Black olive 45" 16.25" dbh

Over lifted canopy, poor structure (codominant stems), dogleg present, cross branching, flush cuts, small branch deadwood present, live crown ratio 28%, 29.92' canopy spread diameter, inside of raised planter box with evidence of curb uplift from roots, tree condition is fair.

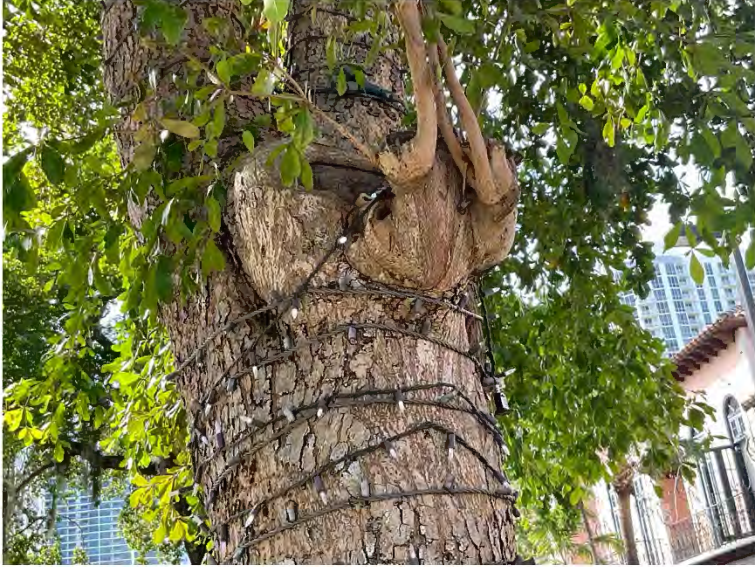
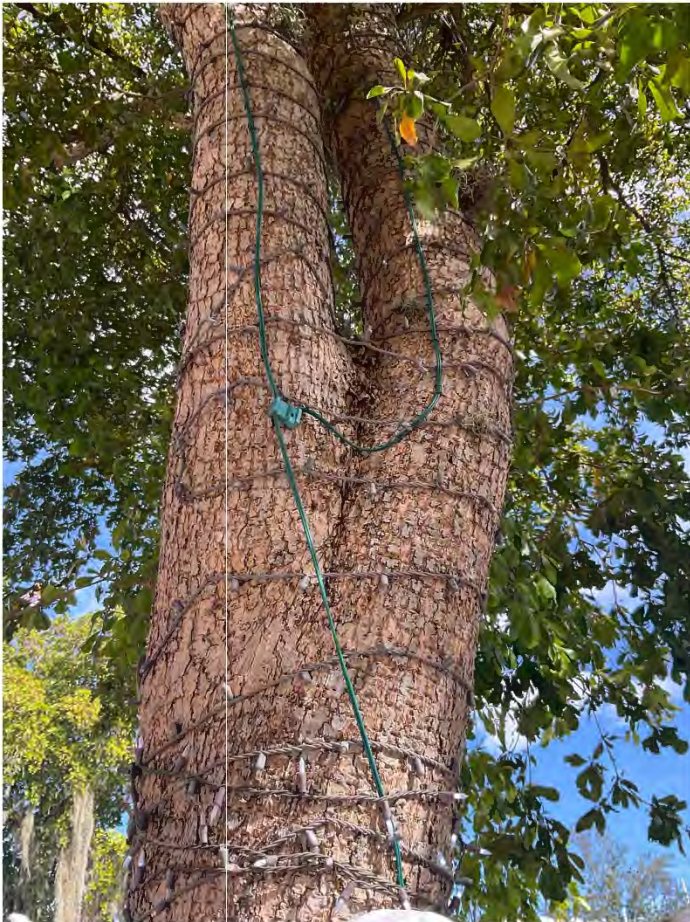
Tree 13
October 2023 update
16.75" DBH

No significant changes in health or condition from previous observations noted.

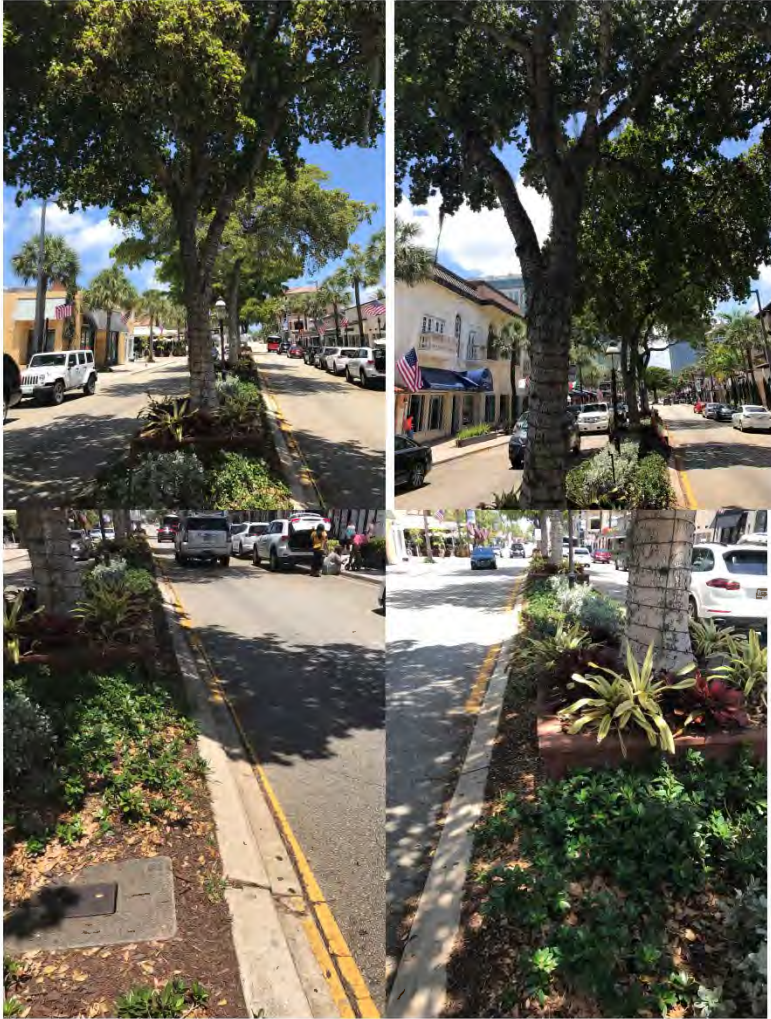
Tree 14

Black olive 46.5" 16.75" dbh

Over lifted canopy, poor structure (codominant stems), small branch deadwood present, flush cuts, poor angles of scaffold limb attachment, live crown ratio 28%, 26.70' canopy spread diameter, inside of raised planter box with evidence of curb uplift from roots, tree condition is fair.

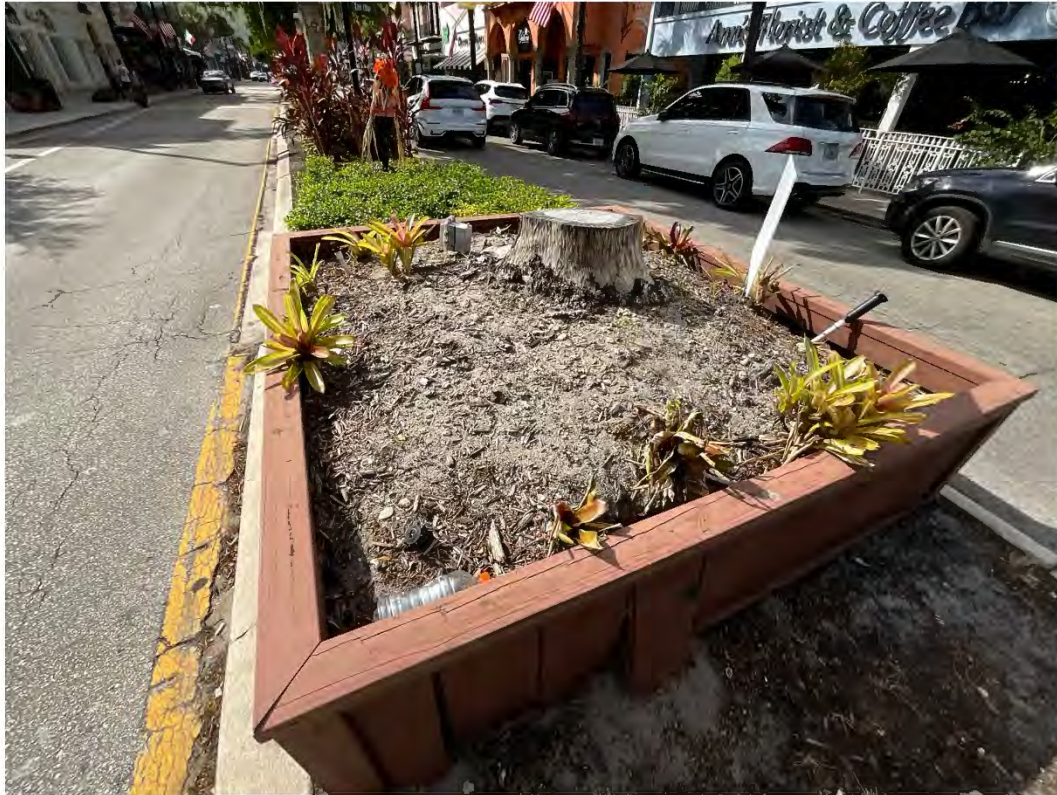
Black olive ~~15.5"~~ 15.75" dbh

Over lifted canopy, flush cuts, poor structure (poor angles of scaffold limb attachment), small branch deadwood present, leaf chlorosis, live crown ratio 27%, 35' canopy spread diameter, inside of raised planter box with evidence of curb uplift from roots, tree condition is fair/poor.

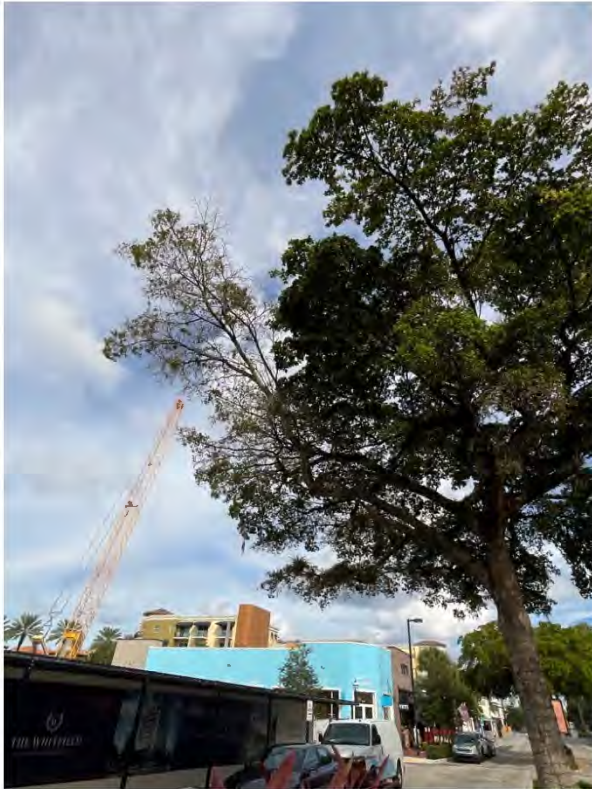
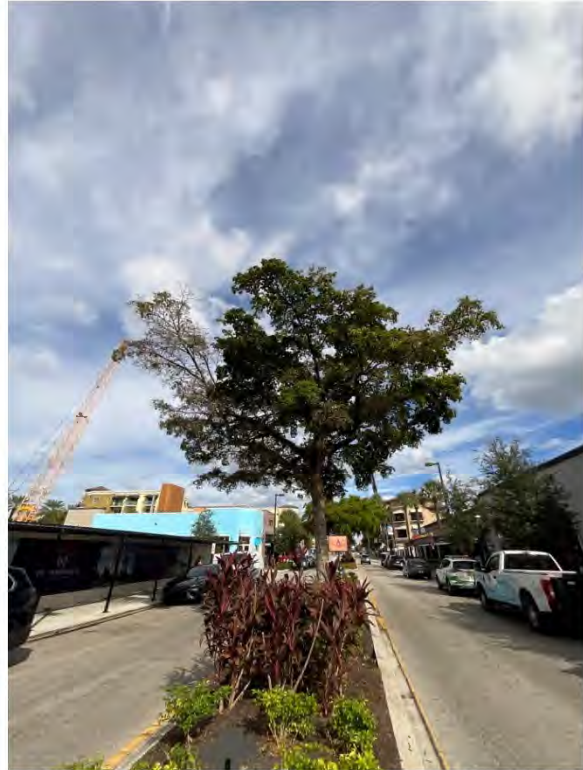
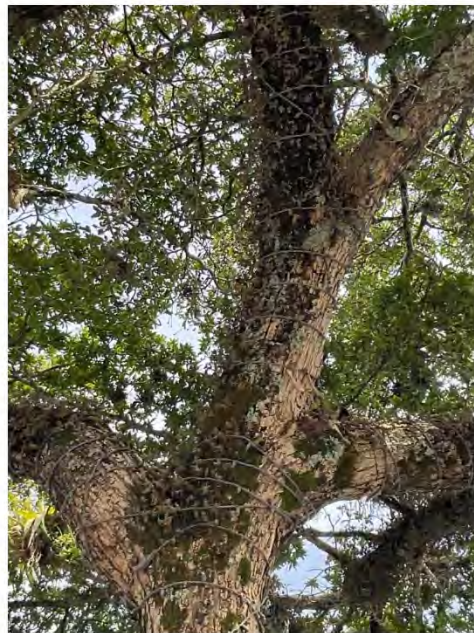
Tree 16
October 2023 update
16" DBH

Vertical cracking and obvious dieback of twigs and branch tips. Monitor over 3 months to determine if the rate of decline has continued to accelerate. Live crown ratio 25%, overall condition rating 28% Removal may be recommended.

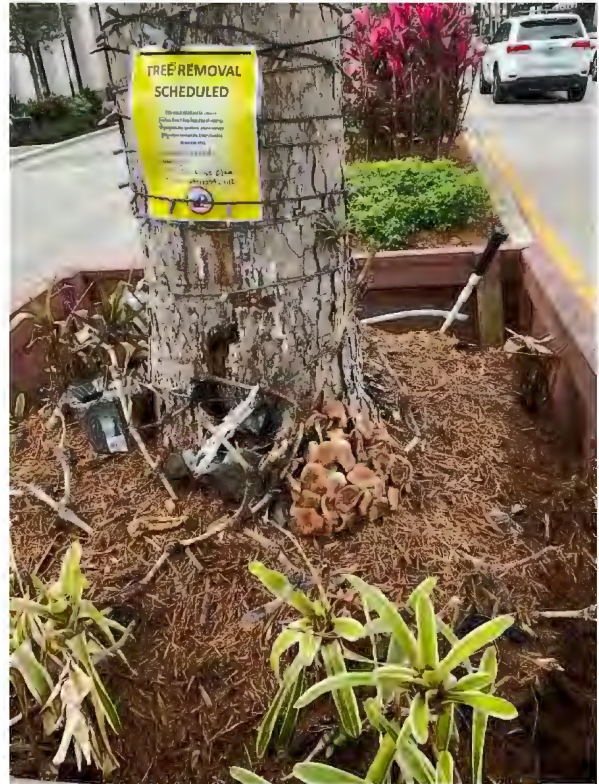
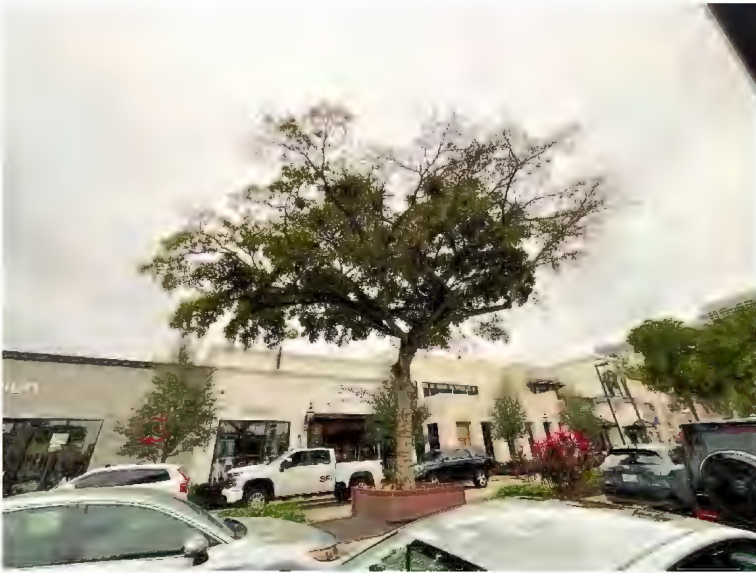
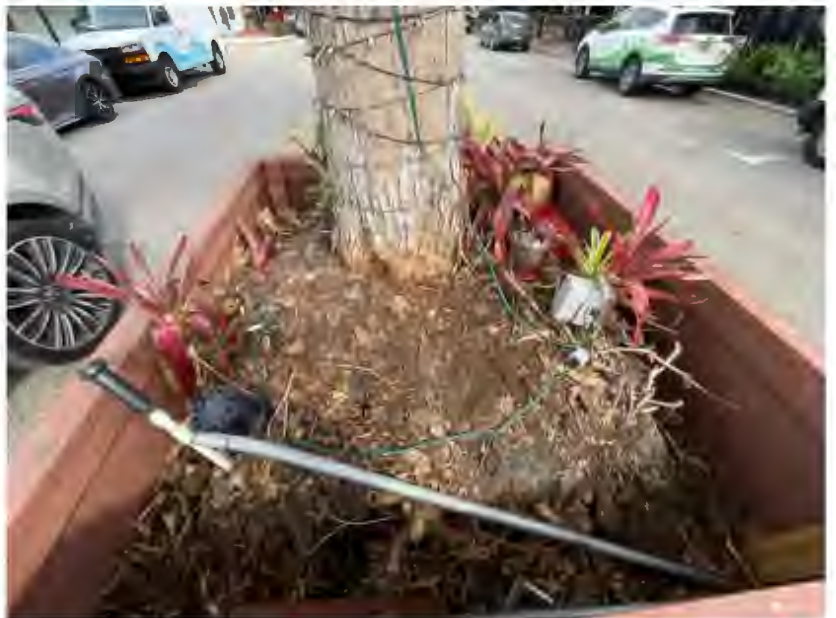
Tree 16
1010-1012 E Las Olas Blvd.

Condition of canopy has continued to decline with major dieback becoming evident. Tree has been permitted and posted for removal as soon as possible. Live crown ratio 23%, overall condition rating 18%.

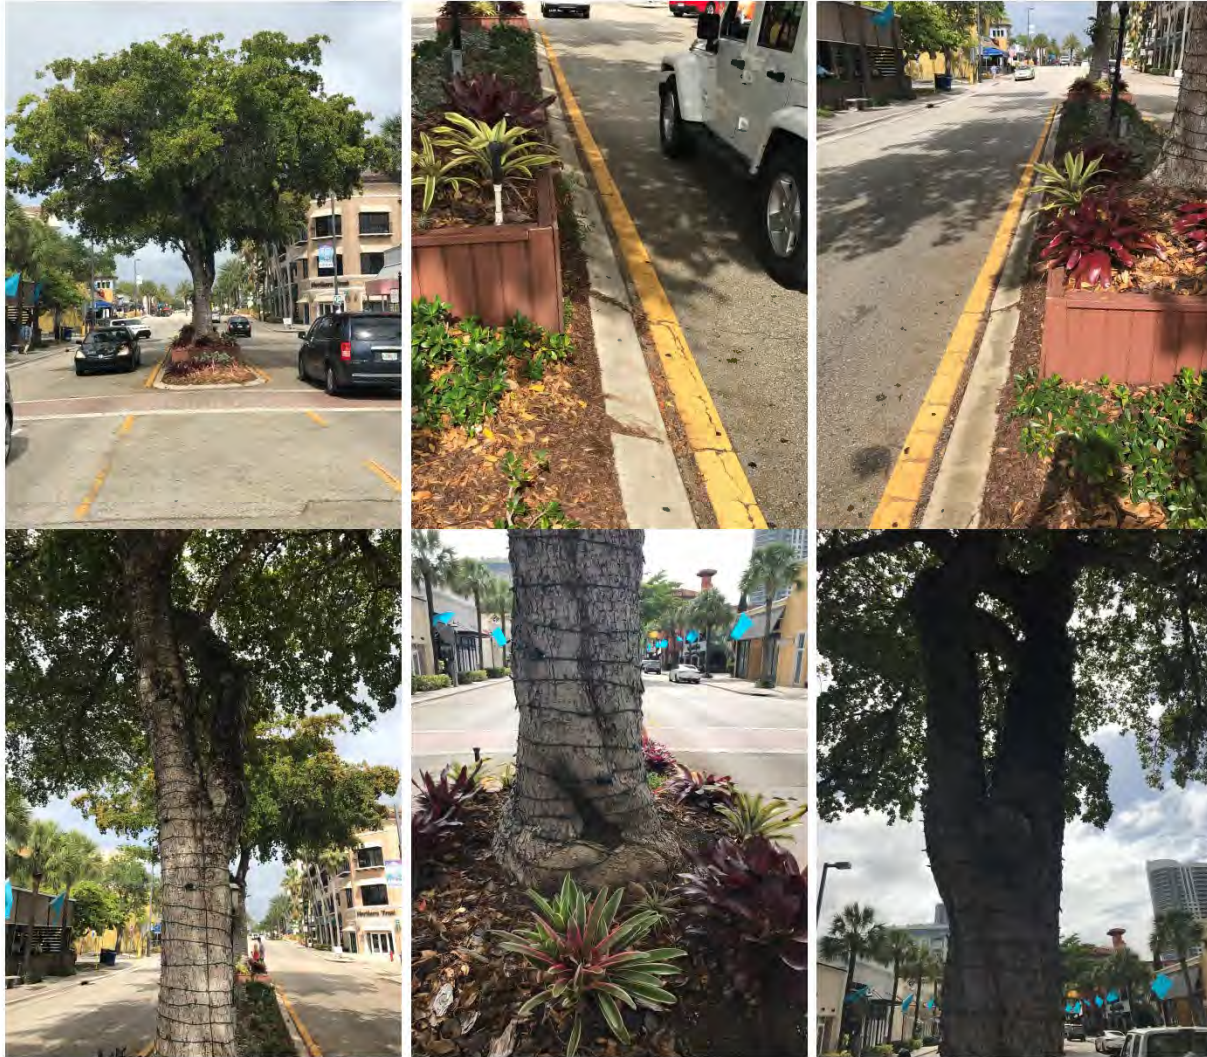
Tree 17

Black olive 21" 21.25" dbh

Over lifted canopy, large trunk wound with decay visually evident, poor structure (codominant stems, dogleg, poor angles of scaffold limb attachment), small branch deadwood present, leaf chlorosis, live crown ratio 27%, 36.56' canopy spread diameter, inside of raised planter box with evidence of curb uplift from roots, tree condition is fair/poor.

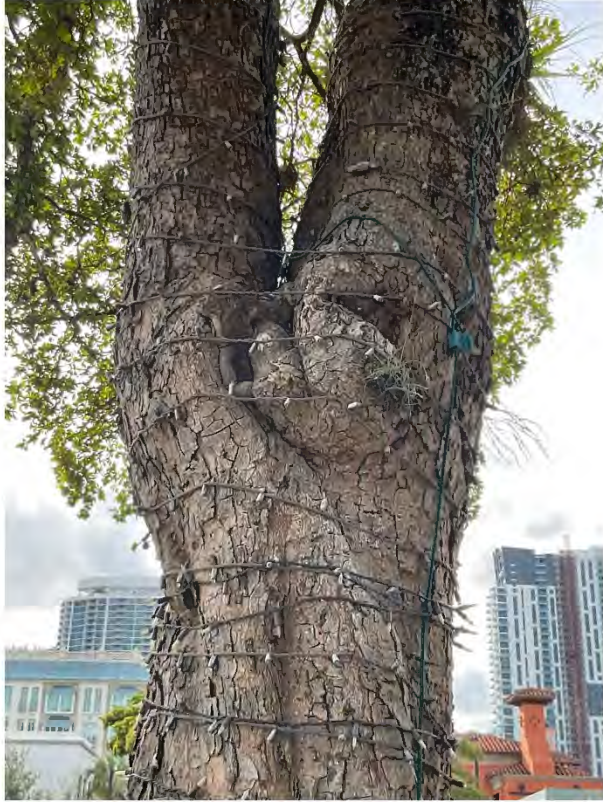
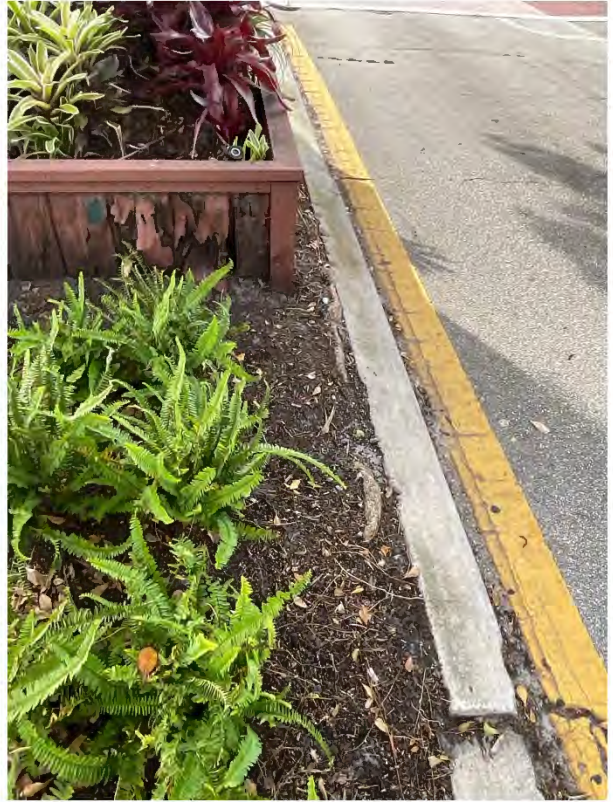
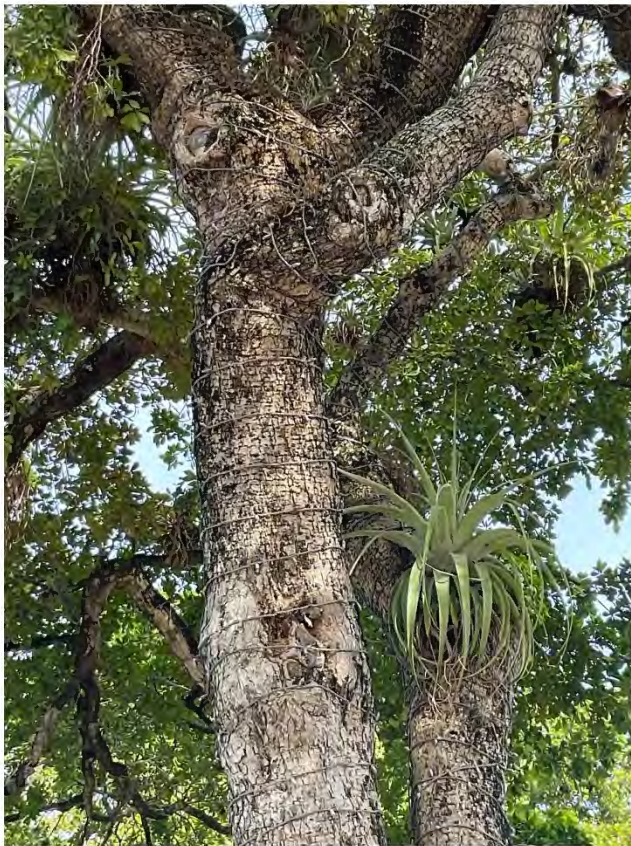
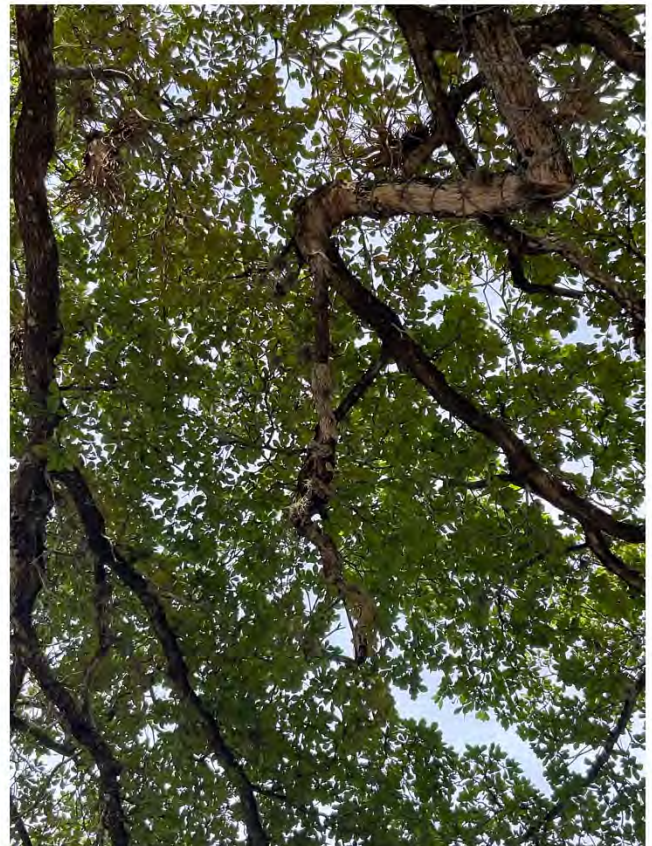
October 2023 update
22" DBH

No significant changes in health or condition from previous observations noted.

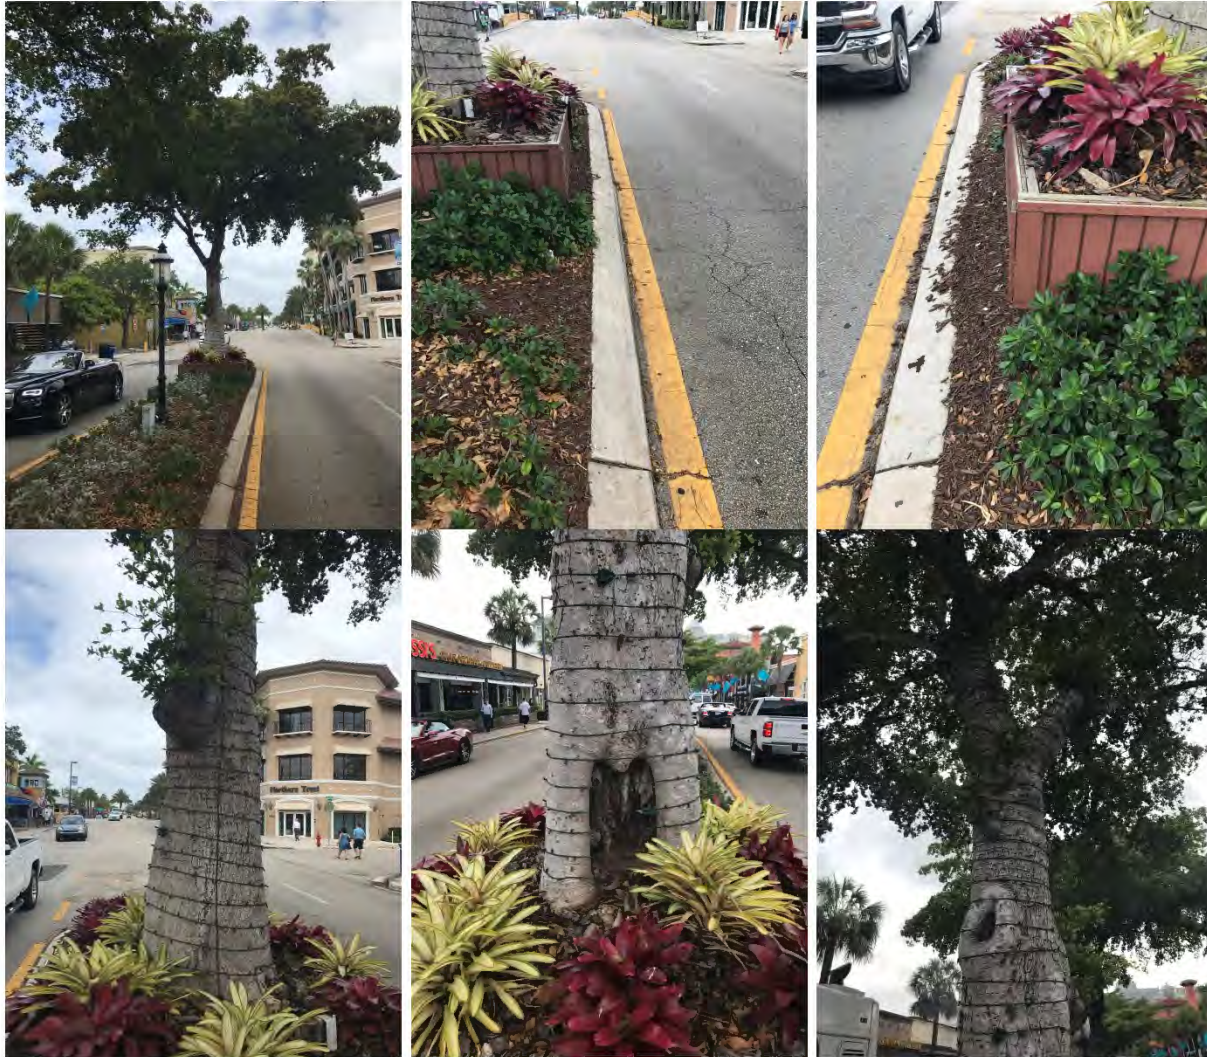
Tree 18

Black Olive 22" 22.5" dbh

Over lifted canopy, large trunk wound with good reaction wood and decay visually evident, poor structure (poor angles of scaffold limb attachment), water sprouts, small branch deadwood present, leaf chlorosis, live crown ratio 21%, 34.2' canopy spread diameter, inside of raised planter box with evidence of curb uplift from roots, tree condition is fair/poor.

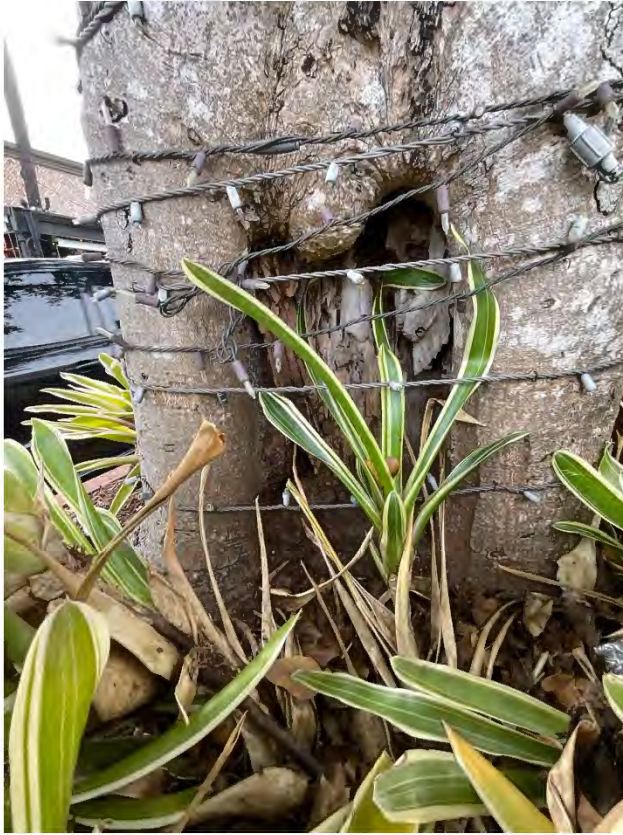
East side

22.5" DBH

Tree is in fair/poor condition with signs of decline. Decay previously noted has progressed from one side of trunk through to opposite side of trunk.
