# City of Fort Lauderdale Las Olas Boulevard Mobility Study

## Executive Summary

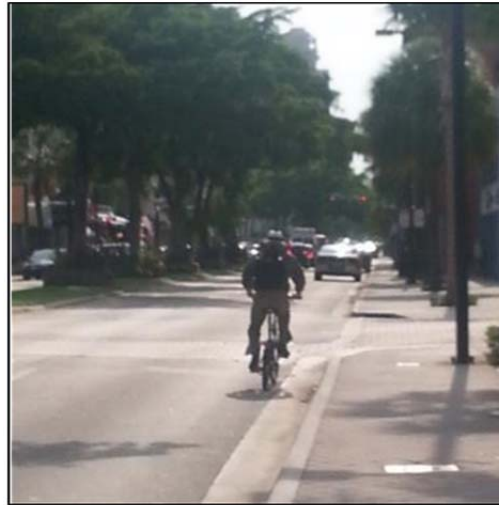
Cyclist hugging curb

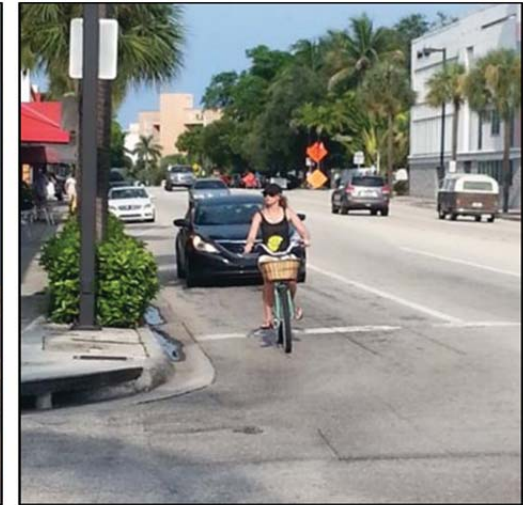
Cyclist “taking” the lane

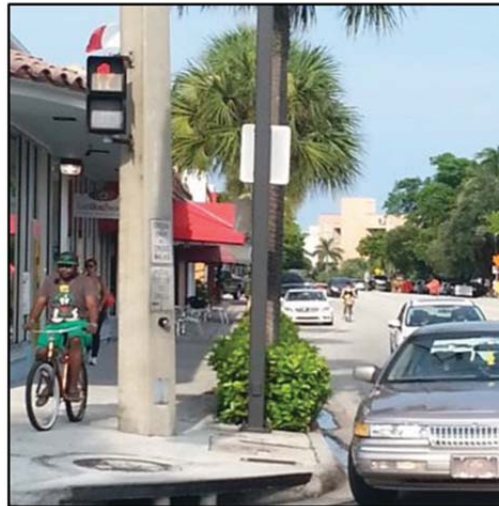
Cyclist on sidewalk with traffic

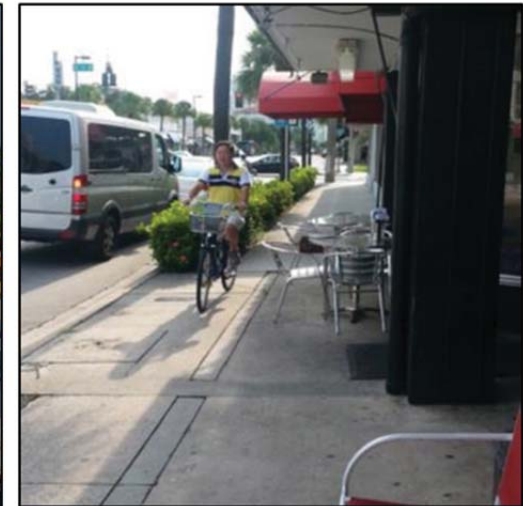
Cyclist on sidewalk against traffic

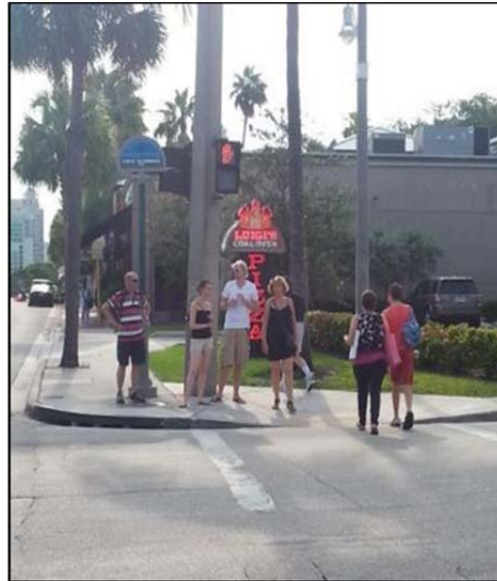
- Worn crosswalk markings at the signalized intersection of Las Olas Boulevard and SE 15<sup>th</sup> Avenue as well as the mid-block crosswalk at SE 13<sup>th</sup> Avenue
- No pedestrian crossing across the east leg of the intersection of Las Olas Boulevard and SE 15<sup>th</sup> Avenue
- Conflict between heavy westbound to northbound right turn flow at Las Olas Boulevard and SE 15<sup>th</sup> Avenue, with pedestrians/cyclists crossing the north leg of the intersection
- Appropriate signing, pavement marking, and warning beacon devices not applied to marked mid-block crosswalks
- Opportunities to improve crosswalk area lighting

Worn crosswalk markings across 15<sup>th</sup> Ave.

- Re-stripe lateral crosswalk markings and increase the “target value” by adding supplemental longitudinal bars to the existing crosswalks in the corridor including the three marked crosswalks at the intersection of SE 15<sup>th</sup> Avenue and Las Olas Boulevard and the unsignalized crosswalk at SE 13<sup>th</sup> Avenue.

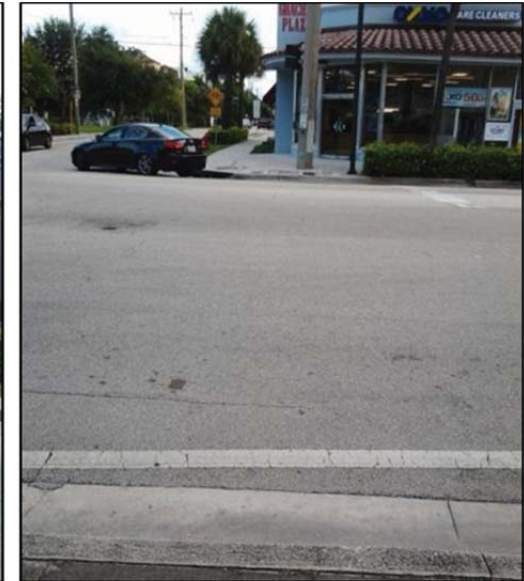
Missing Crosswalk across Las Olas

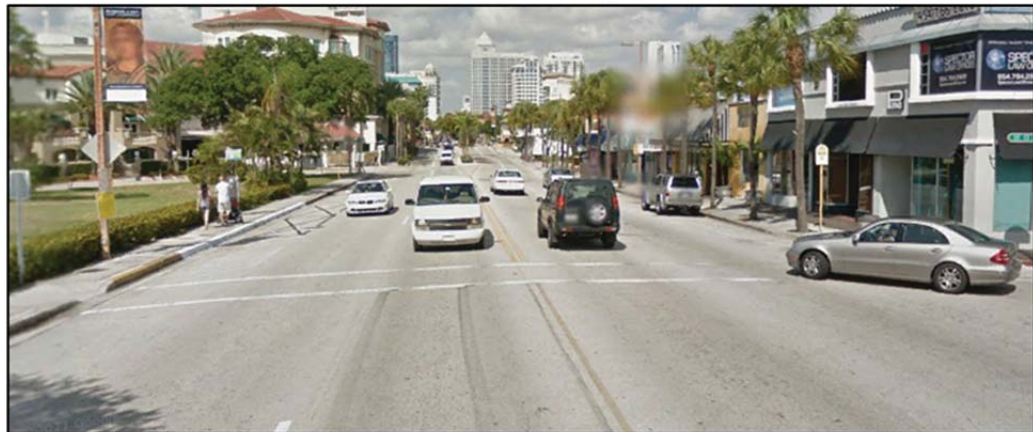
Worn mid-block crosswalk markings – opportunity to provide enhanced crosswalk

- At the unsignalized crosswalk at SE 13<sup>th</sup> Avenue provide advance stop bar markings and corresponding R1-5 signs to reduce the risk of “multiple threat” crashes, as shown below:

- Install Rectangular Rapid Flashing Beacons (RRFB) or other high-emphasis, pedestrian-actuated warning device to supplement the marked crosswalk at SE 13<sup>th</sup> Avenue.

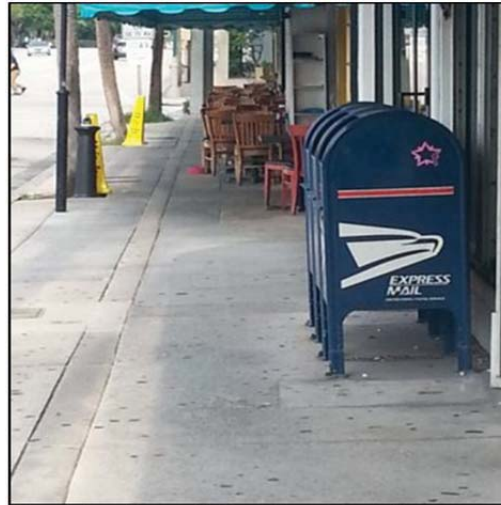
- The sidewalks along Las Olas Boulevard are relatively narrow and, in some cases, are obstructed by café tables and street furniture. While the minimum 3ft accessible path necessary for ADA compliance is generally maintained, features in the sidewalk area frequently constrain the walkable pathway to less than 5ft, the minimum width for two people to walk abreast or walk past one another comfortably. In an urban area such as the Las Olas corridor, a wider pedestrian pathway of 8–12ft is preferred; however, this cannot be accommodated within the current roadway cross section.
- The sidewalk across both canal bridges is relatively narrow and is not buffered from the outside travel lane, making for a less pleasant walking environment. Higher traffic volumes, narrower lanes, and higher motor vehicle volumes and travel speeds across the canal to the east of SE 17<sup>th</sup> Avenue.

Street furniture obstructing sidewalk area

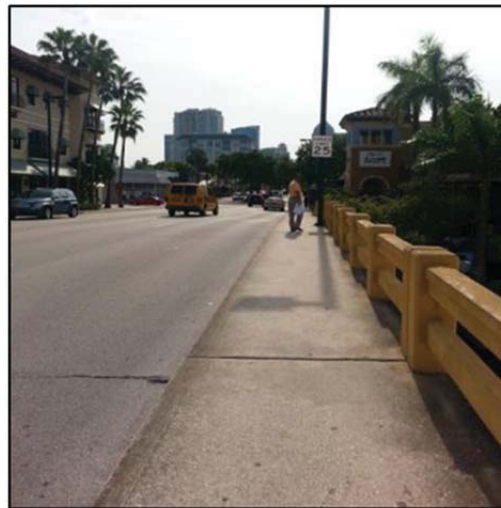
No buffer between traffic and pedestrians on canal bridges along the corridor

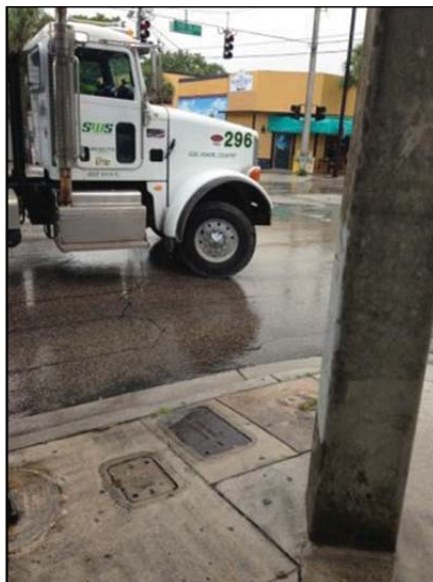
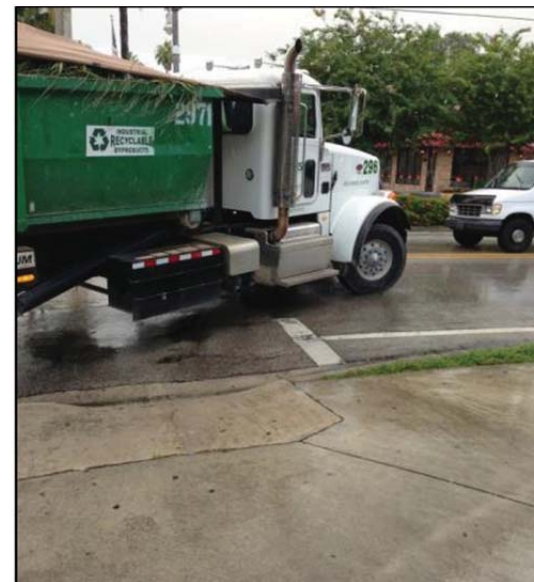
Both the southbound approach at SE 15<sup>th</sup> Avenue and Las Olas Boulevard and the northbound approach at SE 15<sup>th</sup> Avenue and Broward Boulevard are approximately 30ft wide from curb to curb with the roadway centerline striped at the approximate center of the pavement. To complete right turns onto SE 15<sup>th</sup> Avenue, trucks must turn very slowly using every inch of the available roadway cross-section (top right and bottom left photos). When possible, trucks were observed crossing into the inside lane prior to initiating right turns in order to provide for a larger effective radius (top left photo).

Even with these measures, damage was observed on the drainage inlet on the northeast corner of SE 15<sup>th</sup> Avenue and Las Olas Boulevard and to the inlet, shoulder, curb, and sidewalk on the southwest corner of SE 15<sup>th</sup> Avenue and Broward Boulevard.

Large single-unit truck turning wide at Las Olas Blvd. and 15<sup>th</sup> Avenue

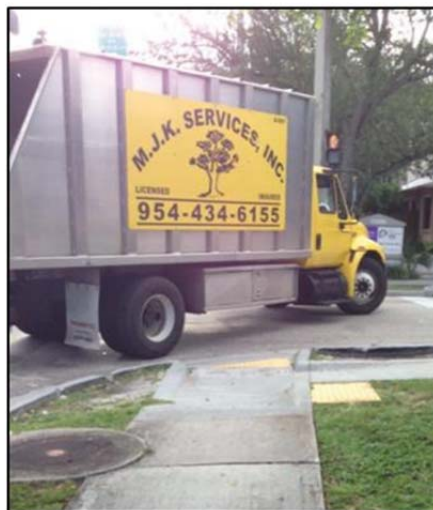
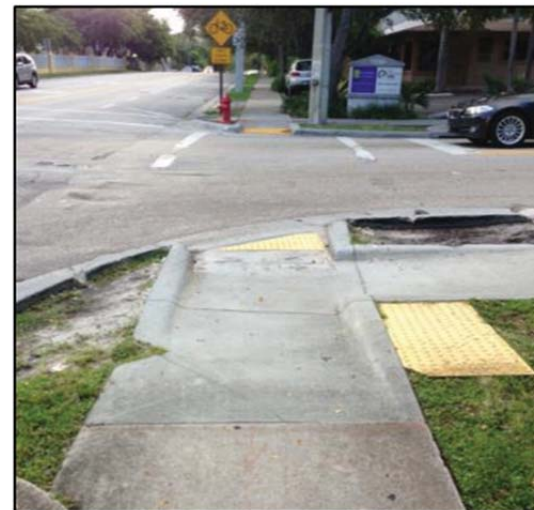
Single-unit truck turning wide at Broward Blvd; damage to curb and sidewalk

***Modify the centerline and stop bar placement at the south leg of SE 15<sup>th</sup> Avenue and Broward Boulevard to facilitate truck turning movements.***

Observations of damage to the curb, pedestrian ramp, and storm-water inlet on the southwest corner of the intersection of SE 15<sup>th</sup> Avenue and Broward Boulevard and field observations of single-unit trucks navigating the intersection indicates the need to modify the intersection to better enable trucks to navigate the eastbound to southbound right turn. A short term option to address this issue (pictured to the right) is to remove the existing stop bar and centerline markings on the south leg of the intersection and reposition as follows:
