Re: Las Olas Black Olive Tree Status Report

Las Olas Boulevard Black Olive Trees

CITY OF FORT LAUDERDALE

January 2024

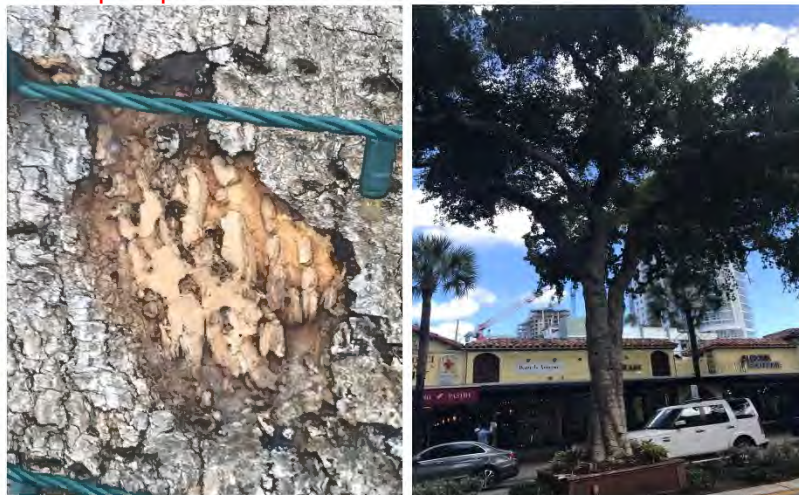
Over lifted canopy, poor structure (poor angles of attachment/included bark), swollen/sunken areas of trunk indicating possible presence of decay, leaf chlorosis, live crown ratio of 35-40%, visible decay with carpenter ants present, tree condition is fair, 43.9' canopy spread diameter, inside of raised planter box with evidence of curb uplift from roots.

Roots appear to be lifting planter box above existing grade. Minimal trunk growth over the four-year period since last measured. Tree remains in fair condition.

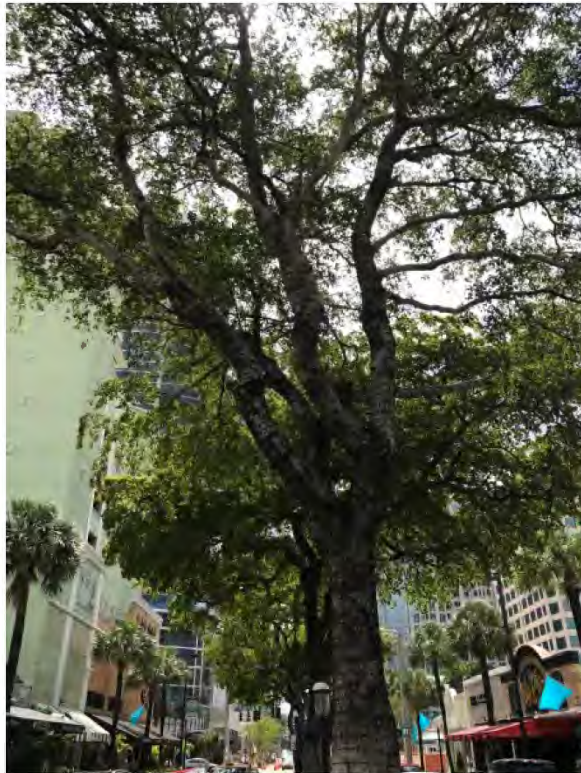
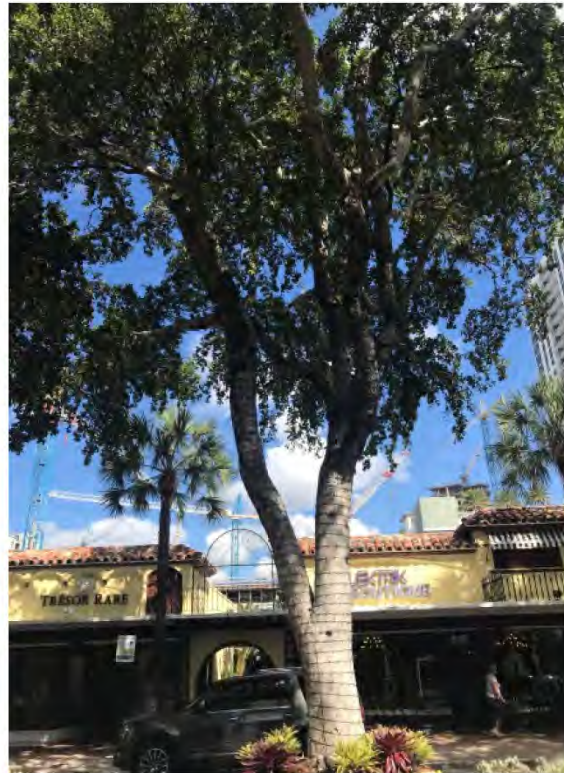
Over lifted canopy, poor structure (codominant stems with included bark), small branch deadwood, leaf chlorosis, live crown ratio of 20-25%, 44.2' canopy spread diameter, inside of raised planter box with evidence of curb uplift from roots, tree condition is fair/poor.

No significant changes in health or condition from previous observations noted.

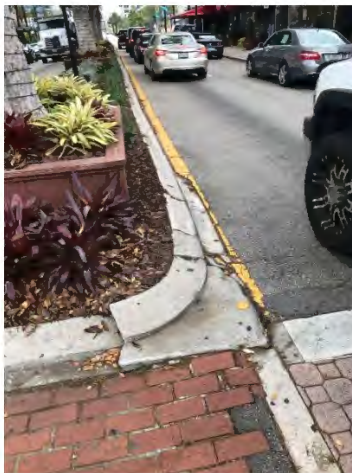
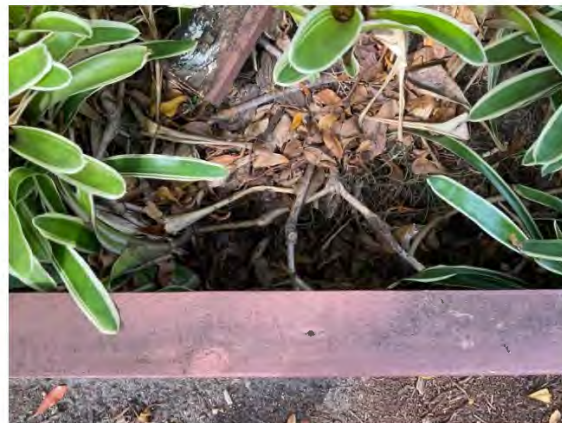
Tree 6
October 2023 update
26.5" DBH

Over lifted canopy, poor structure (codominant stems with included bark), flush cuts, leaf chlorosis, small branch deadwood, branch stubs, live crown ratio 20-25%, 45.67' canopy spread diameter, inside of raised planter box with evidence of curb uplift from roots, tree condition is fair/poor.

No significant changes in health or condition from previous observations noted.

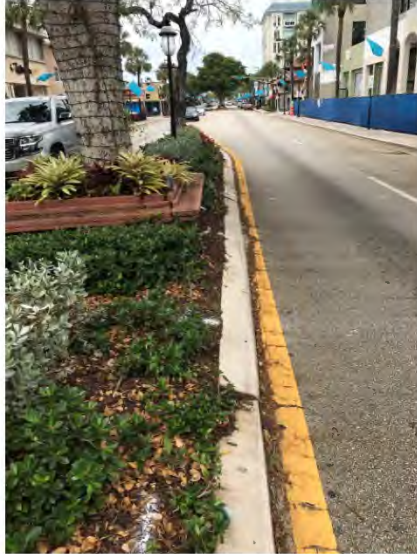
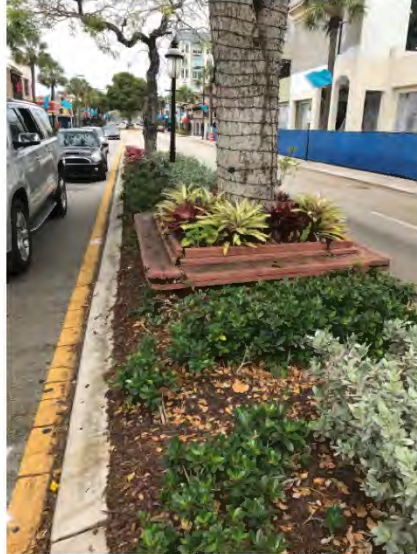
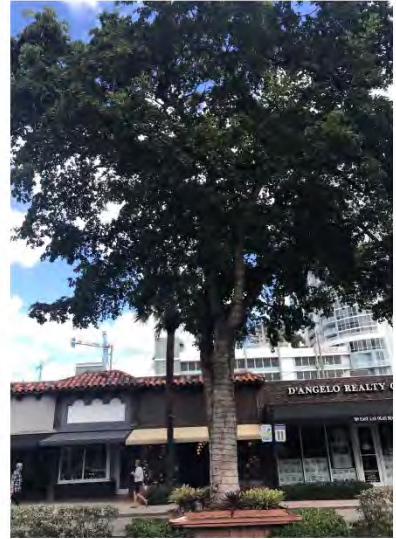
Tree 7
October 2023 update
24" DBH

Over lifted canopy, sunken areas present in trunk indicating possible decay, poor structure (codominant stems with included bark), small branch deadwood, improper pruning cuts, live crown ratio 40-45%, inside of raised planter box with evidence of curb uplift from roots, 37.92' canopy spread diameter, tree condition is fair.

No significant changes in health or condition from previous observations noted.

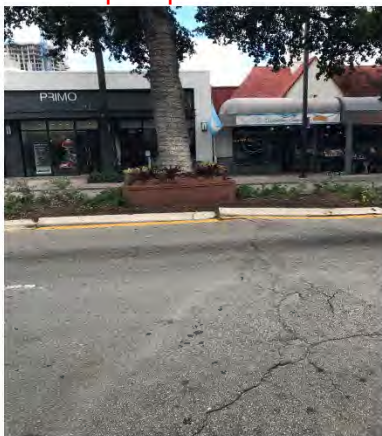
Tree 8

Over lifted canopy, gall present on trunk, past evidence of scaffold limb failure present, small branch deadwood, live crown ratio 50%, 42.55' canopy spread diameter, tree has NW lean with additional root zone uplift on south side, inside of raised planter box with evidence of curb uplift from roots, tree condition is fair.

No significant changes in health or condition from previous observations noted.

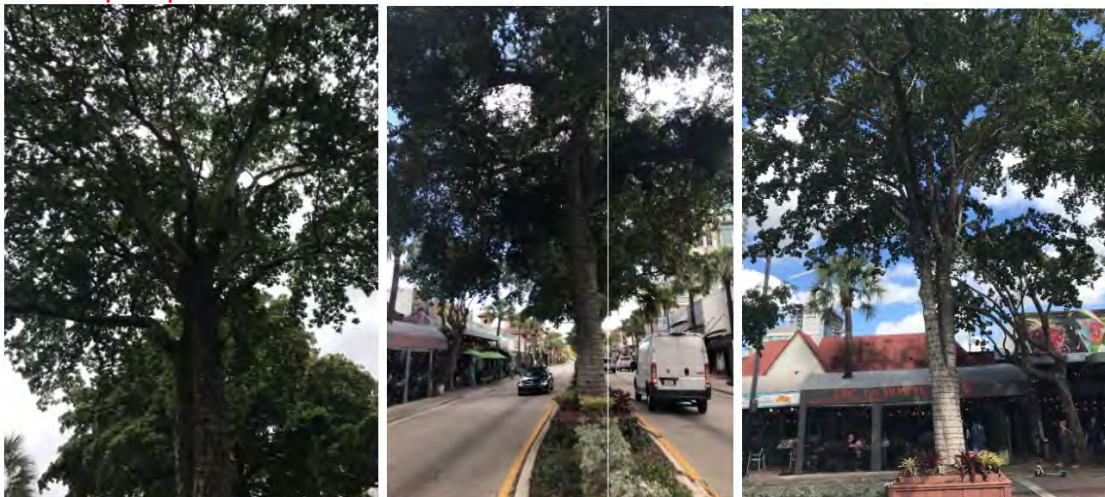
Tree 9

Over lifted canopy, poor structure (codominant stems with included bark), small branch deadwood present, live crown ratio 23%, leaf chlorosis, canopy spread 37.45' canopy spread diameter, inside of raised planter box with evidence of curb uplift from roots, tree condition is fair/poor.

Decay is visibly present causing patches of bark to slough off. Condition is poor.

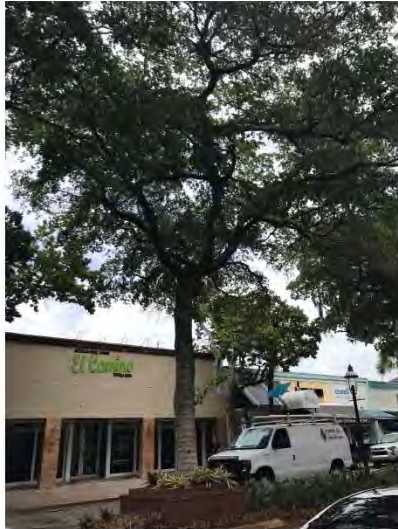
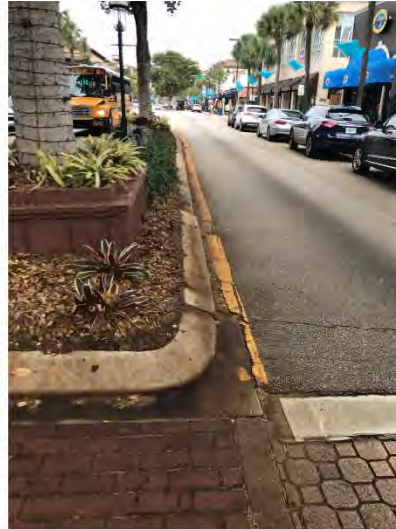
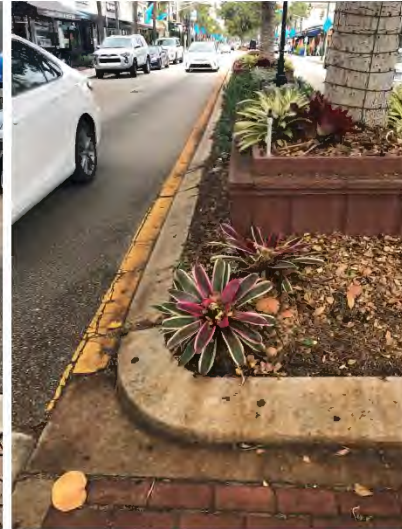
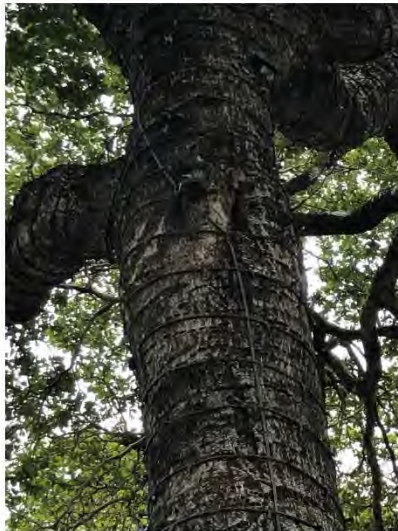
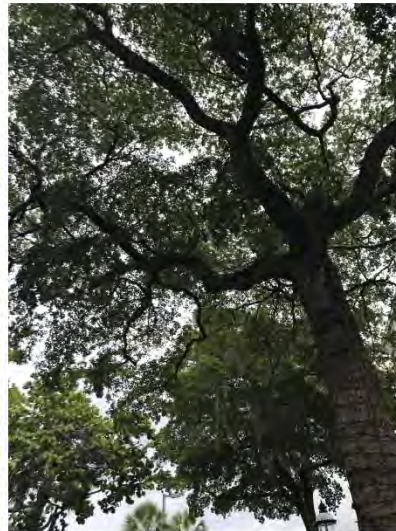
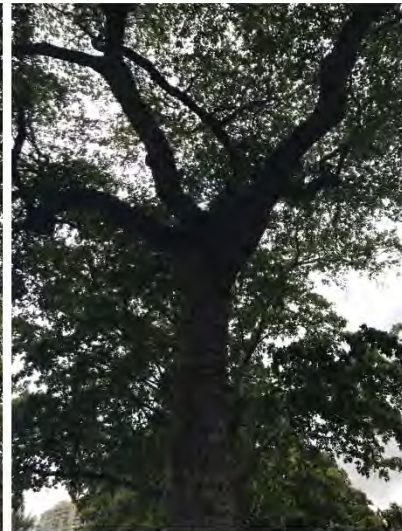
Tree 10
October 2023 update
17.75" DBH

Black olive ~~17"~~ 17.5" dbh
Over lifted canopy, poor structure (poor angles of branch attachment), flush cuts, **medium/large branch deadwood present**, live crown ratio 28%, leaf chlorosis, 36.94' canopy spread diameter, doglegs, inside of raised planter box with evidence of curb uplift from roots, tree condition is fair/poor.

Additional uplift of curbing.

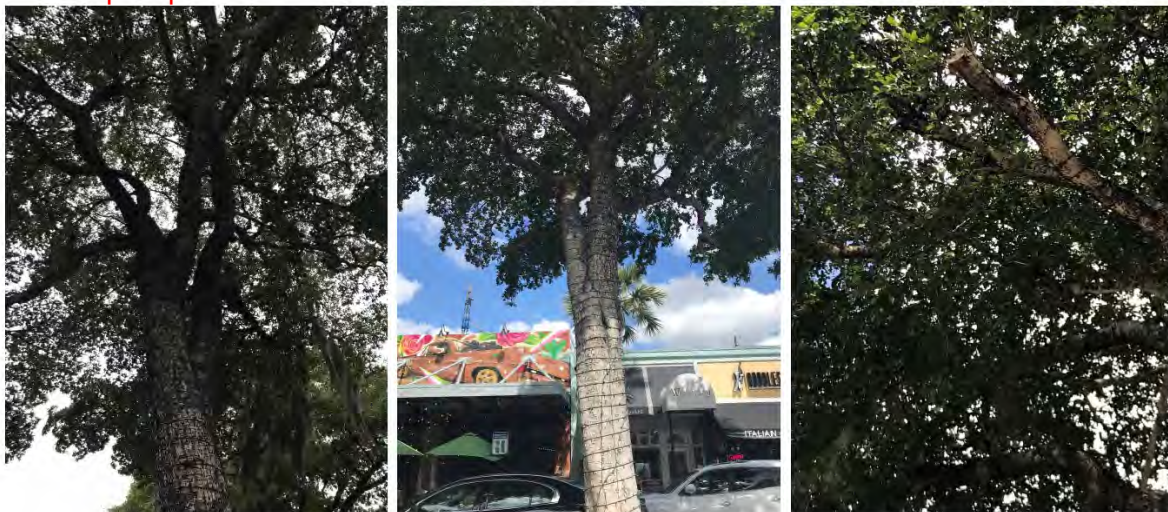
Over lifted canopy, poor structure (codominant stems), flush cuts, **stub cuts**, small branch deadwood, live crown ratio 33%, 36.27' canopy spread diameter, inside of raised planter box with evidence of curb uplift from roots, tree condition is fair.

Large patches of bark are missing. Wound response growth is present but is not likely to provide sufficient coverage to restore structural integrity of trunk. Deadwood is visible on both sides of trunk. Tree condition has declined to poor.

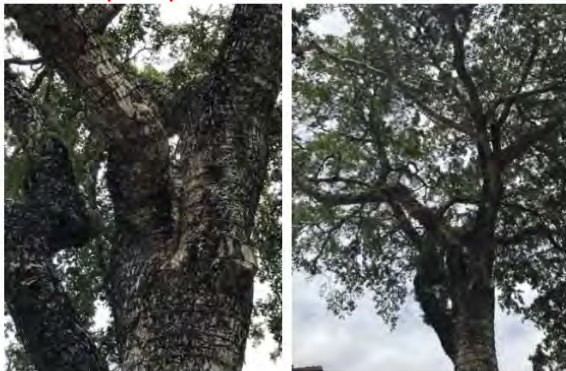
Tree 12

Over lifted canopy, old trunk wound from either flush cut or vehicle strike, flush cuts, poor structure (poor angles of scaffold limb attachment), large branch deadwood present, live crown ratio 25%, 47.01' canopy spread diameter, inside of raised planter box with evidence of curb uplift from roots, tree condition is fair.

No significant changes in health or condition from previous observations noted.

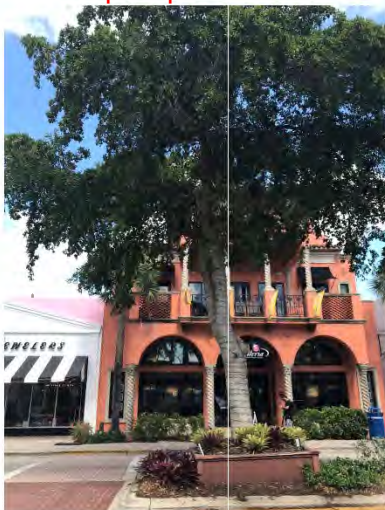
Tree 13
October 2023 update
16.75" DBH

Over lifted canopy, poor structure (codominant stems), dogleg present, cross branching, flush cuts, small branch deadwood present, live crown ratio 28%, 29.92' canopy spread diameter, inside of raised planter box with evidence of curb uplift from roots, tree condition is fair.

No significant changes in health or condition from previous observations noted.

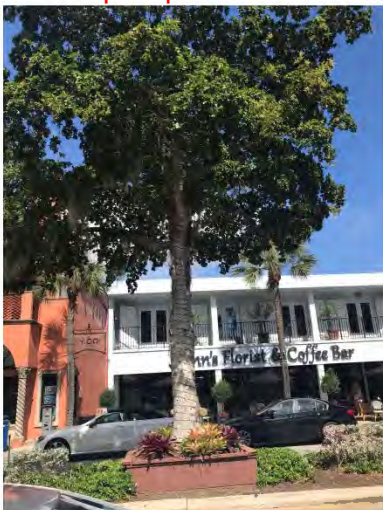
Tree 14
October 2023 update
17.5" DBH

Over lifted canopy, poor structure (codominant stems), small branch deadwood present, flush cuts, poor angles of scaffold limb attachment, live crown ratio 28%, 26.70' canopy spread diameter, inside of raised planter box with evidence of curb uplift from roots, tree condition is fair.

Crown exhibiting some dieback and chlorosis, indicating potential decline in health and continued monitoring required.

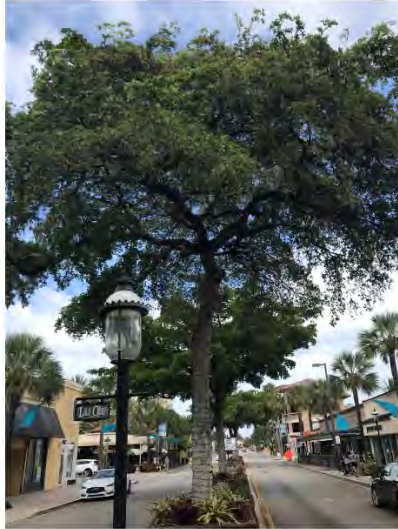
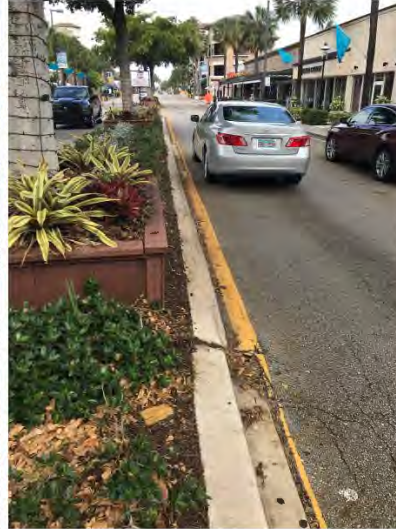
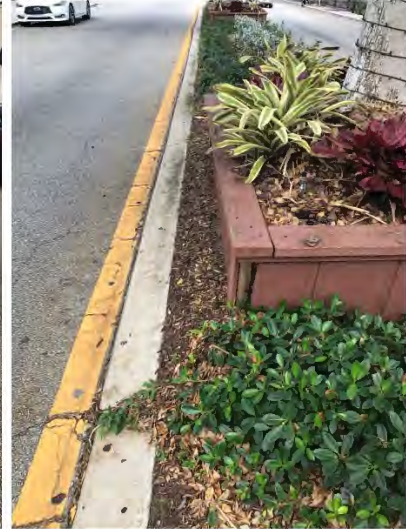
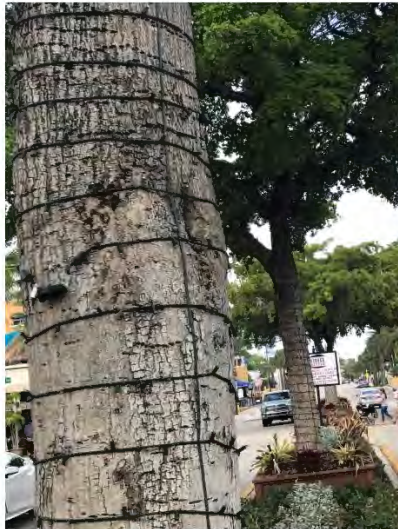
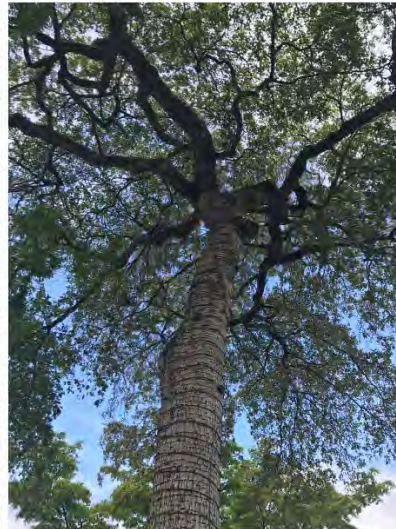
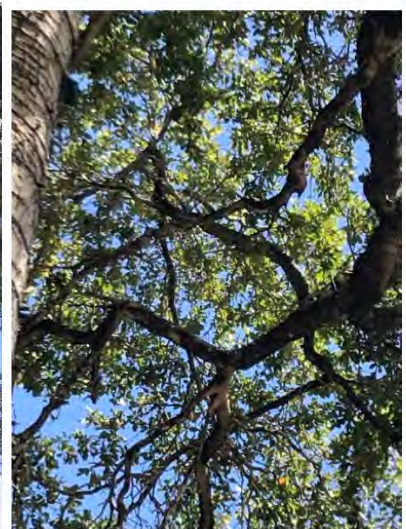
Black olive 17.5" 17.7" dbh

Over lifted canopy, flush cuts, poor structure (poor angles of scaffold limb attachment), large branch deadwood present, leaf chlorosis, live crown ratio 25%, canopy spread diameter 37.97', inside of raised planter box with evidence of curb uplift from roots, tree condition is poor.

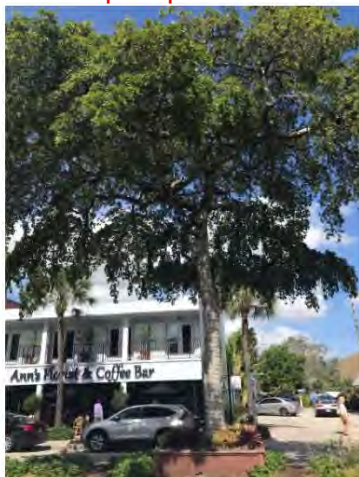
2019 report photo:

Tree has been removed. No additional data available.

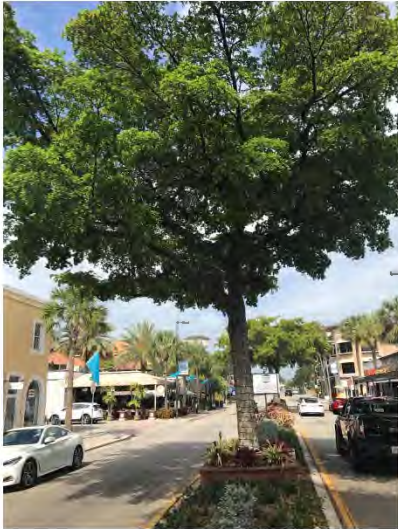
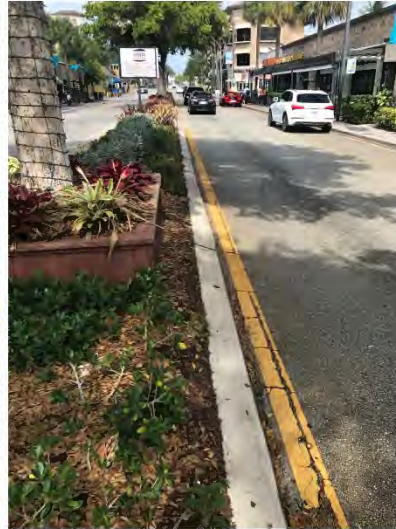
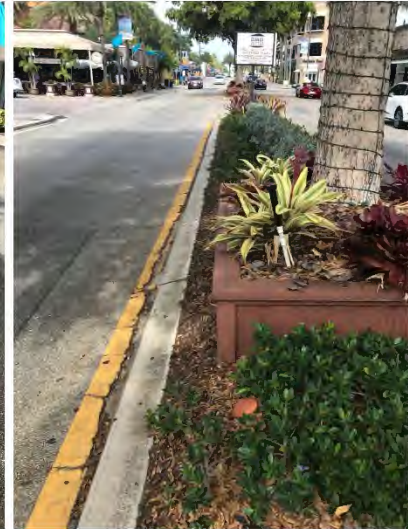
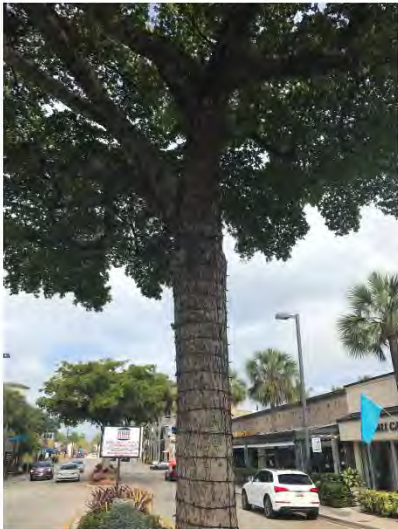
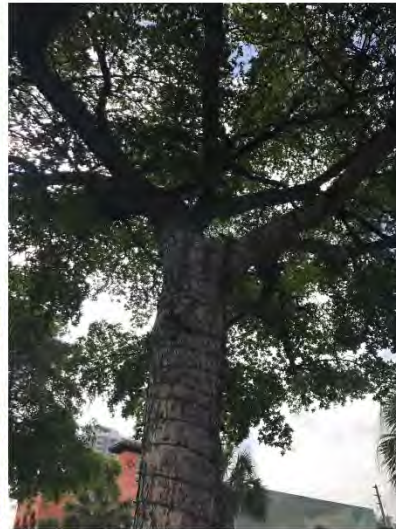
Black olive ~~15.5"~~ 15.75" dbh

Over lifted canopy, flush cuts, poor structure (poor angles of scaffold limb attachment), small branch deadwood present, leaf chlorosis, live crown ratio 27%, 35' canopy spread diameter, inside of raised planter box with evidence of curb uplift from roots, tree condition is fair/poor.

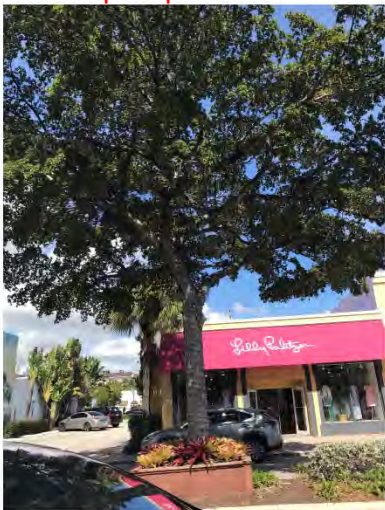
2019 report photo:

Vertical cracking and obvious dieback of twigs and branch tips. Monitor over 3 months to determine if the rate of decline has continued to accelerate. Live crown ratio 25%, overall condition rating 28% Removal may be recommended.

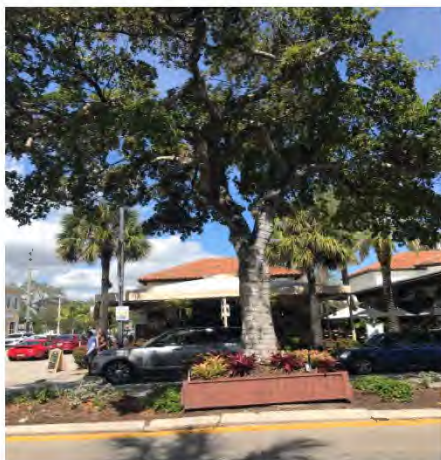
2019 report photo:

No significant changes in health or condition from previous observations noted.

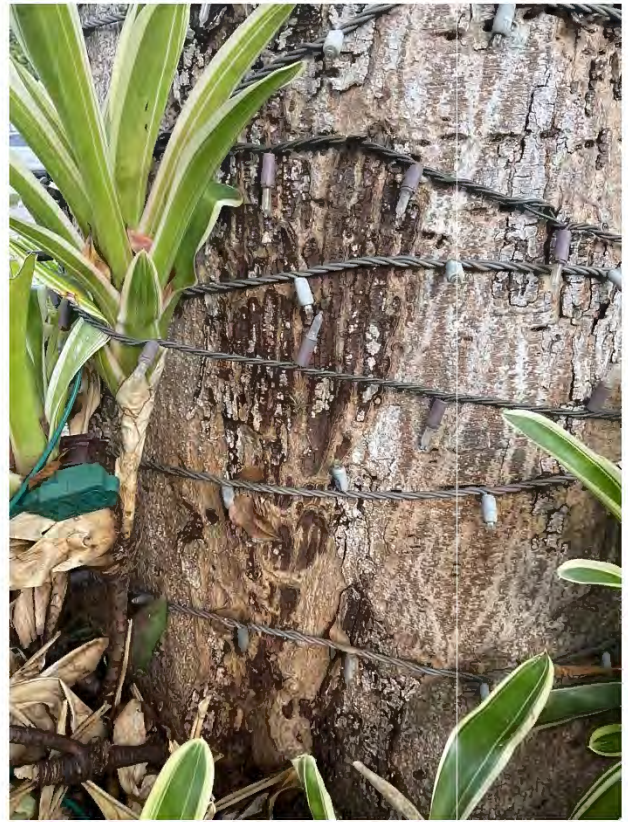
East side

Tree is in fair/poor condition with signs of decline. Decay previously noted has progressed from one side of trunk through to opposite side of trunk.
